## **HOLCOFIRE**

# Behaviour of prestressed hollowcore floors exposed to fire

*Fire case parking garage Lloydstraat, Rotterdam*

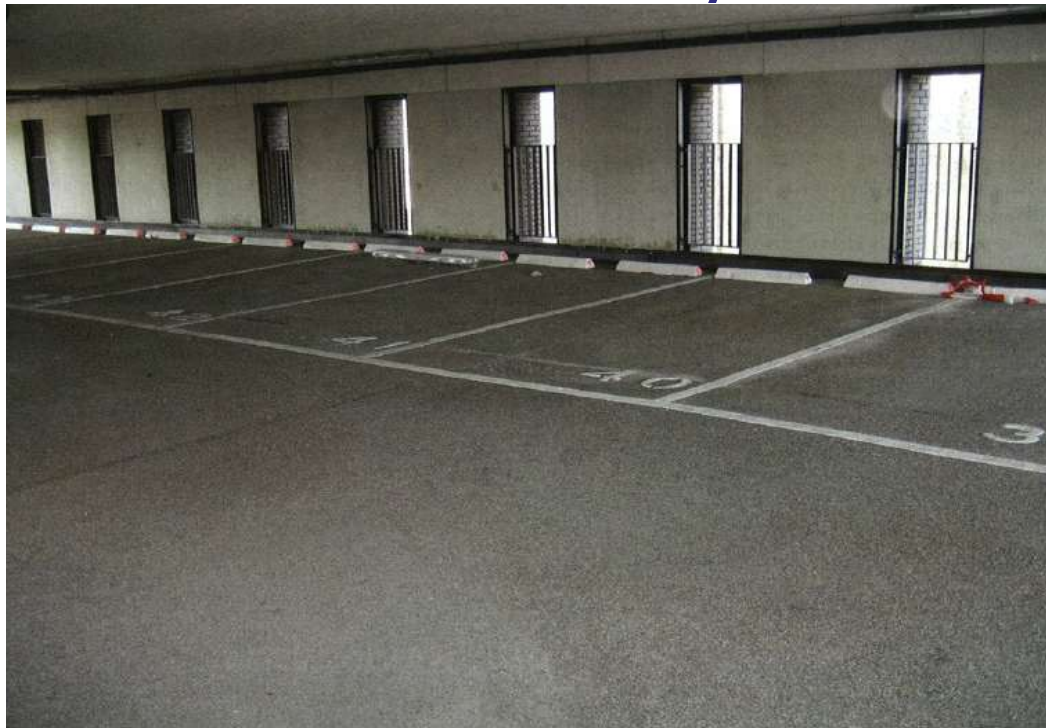
- Floor of level 3 did not collapse !!
- Four cars that were parked on level 3 were removed the next day

One day after the fire  
No damage !!

Criteria REI fulfilled !

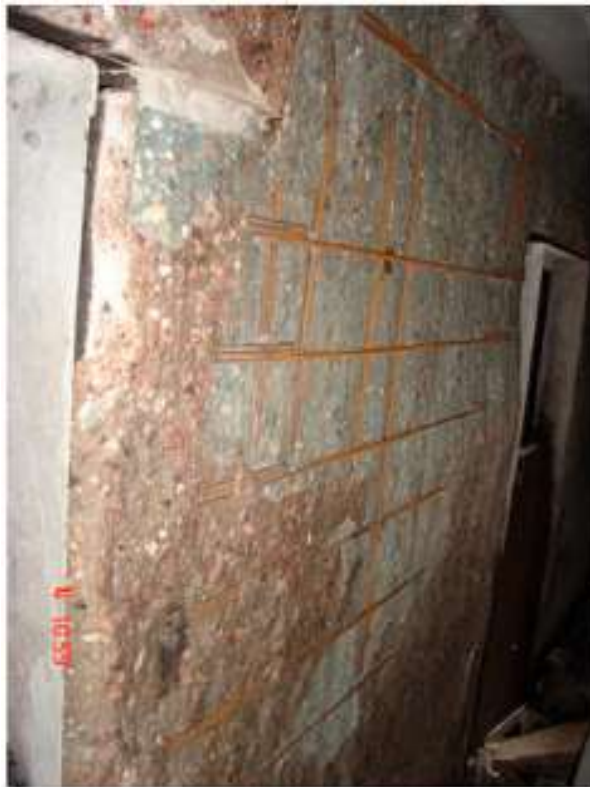
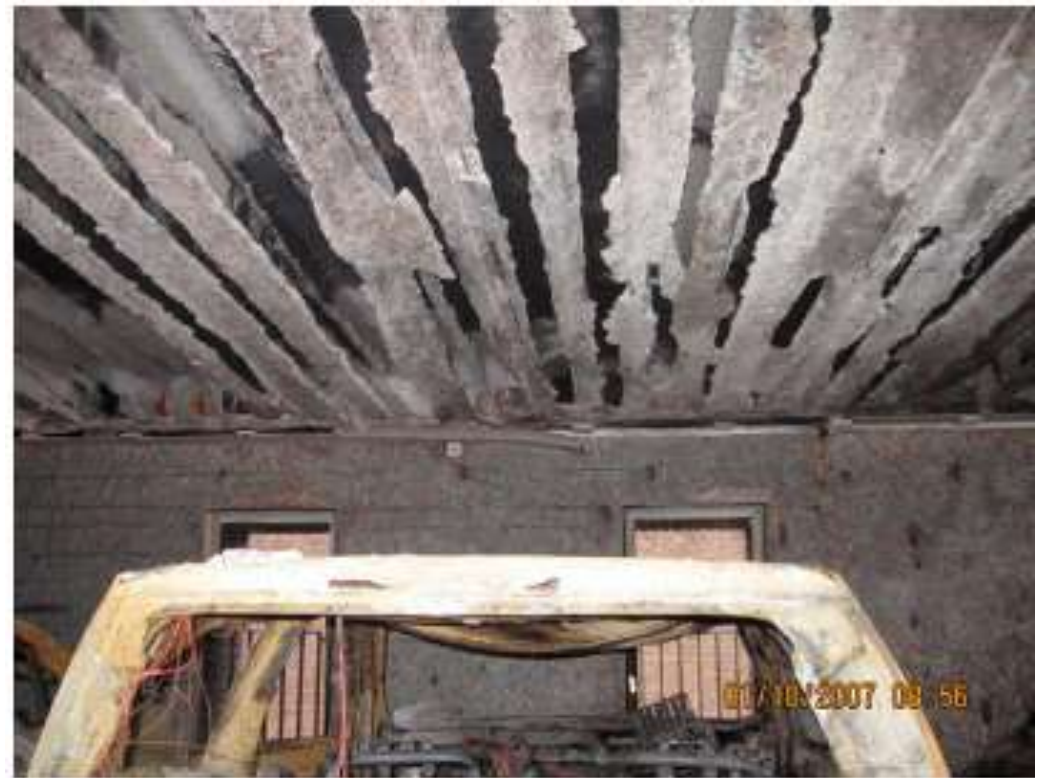
- Extensive spalling on external facade surface (left)
- Hollow core floor ceiling with open cores (right)

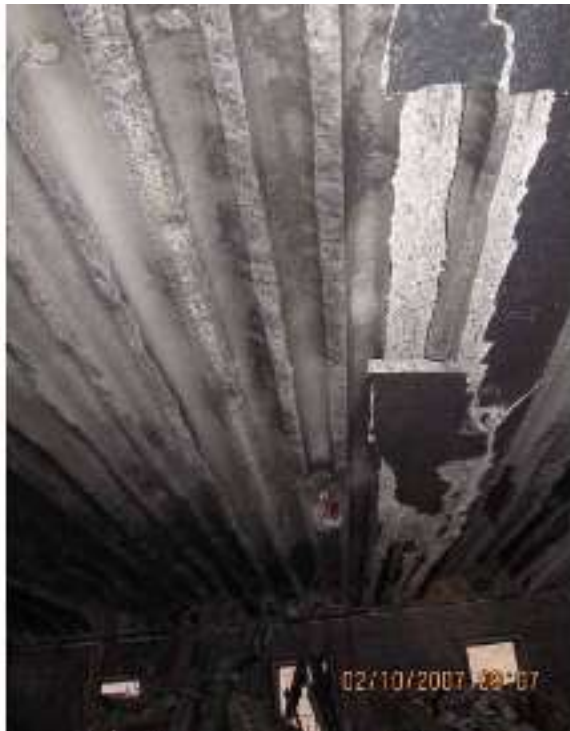
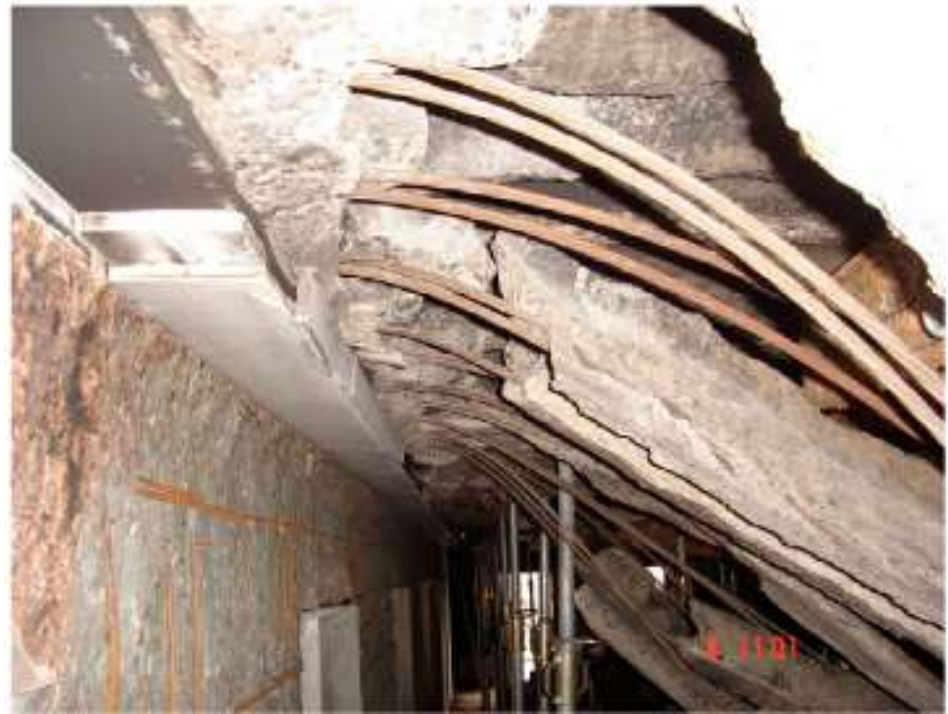
- Underflanges of hollow cores felt down
- Support of the hollow core slab was intact
- Strands were exposed

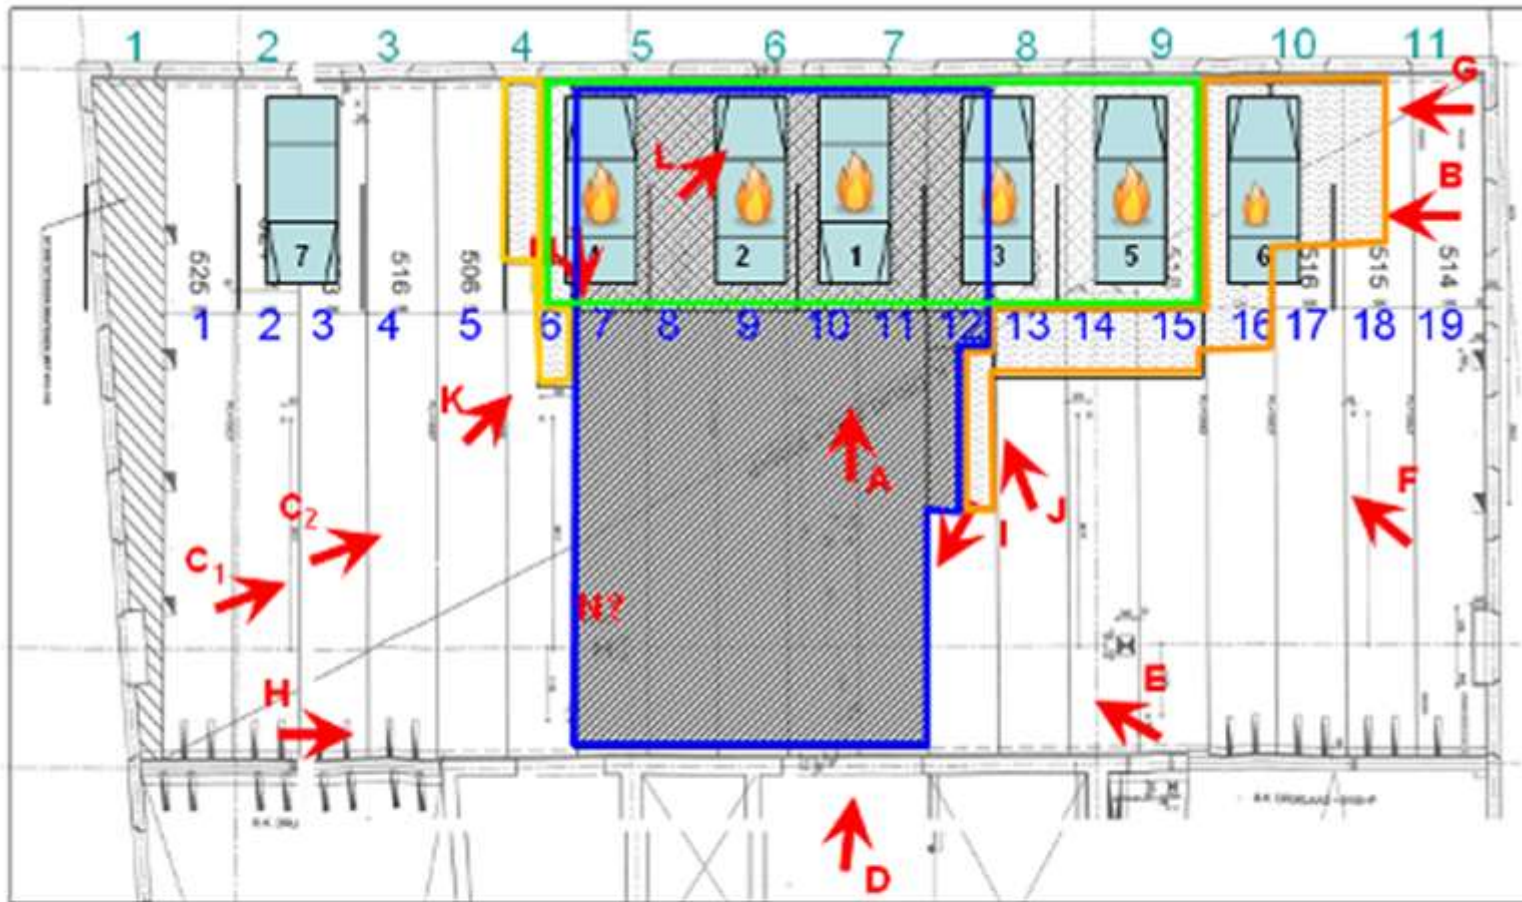
# Damage to slabs: overview

surface spalling   
 spalling with open cores   
 horizontal cracks in webs

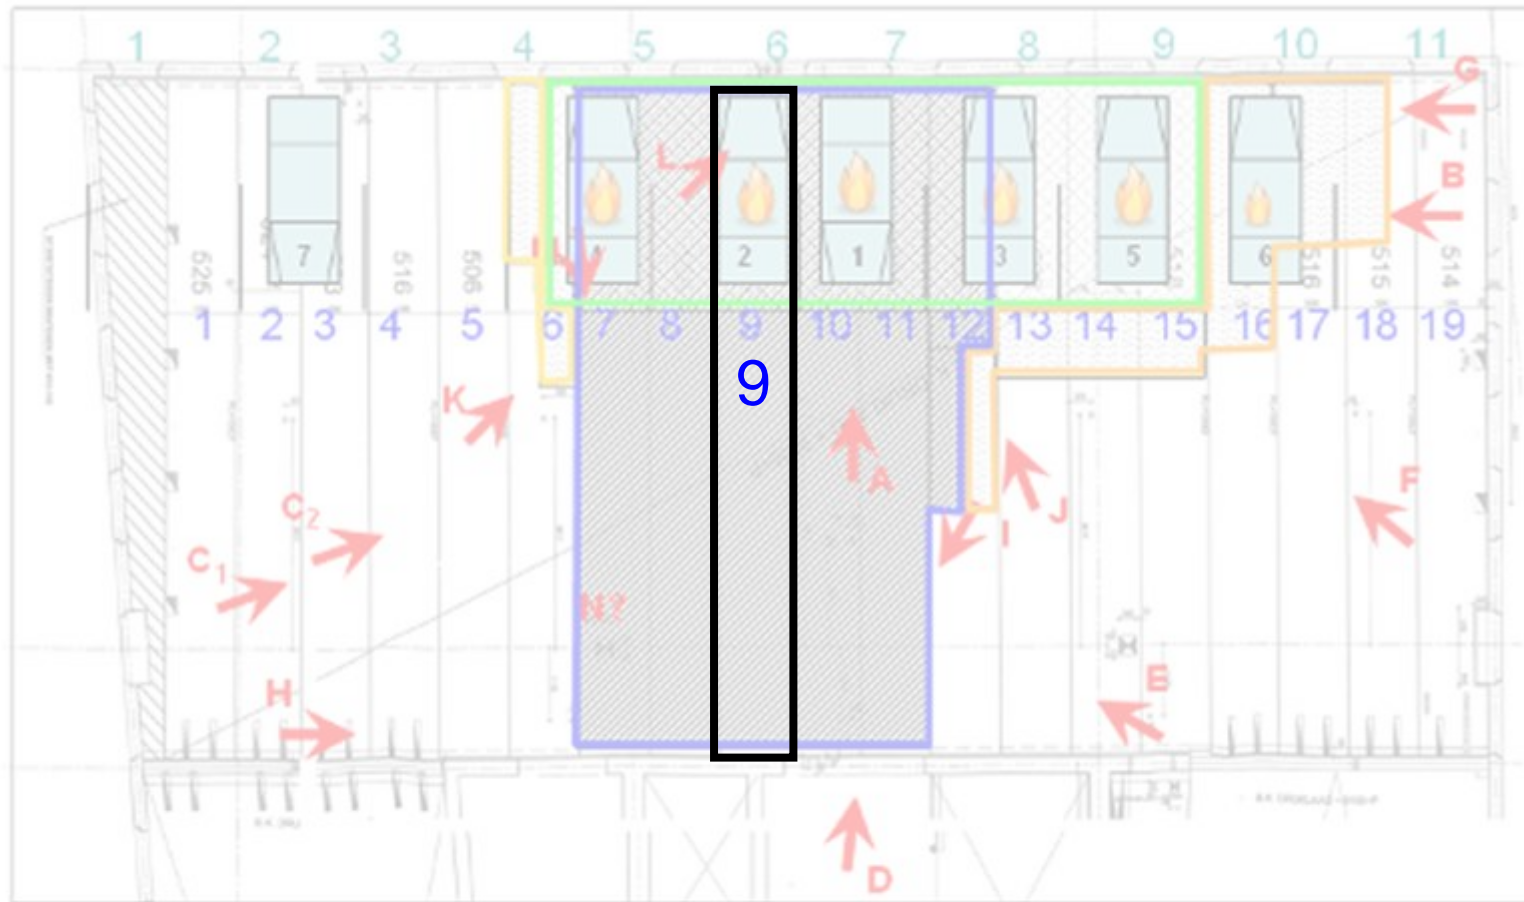
# Focus on slab #9 above car 2

surface spalling  
spalling with open cores  
horizontal cracks in webs

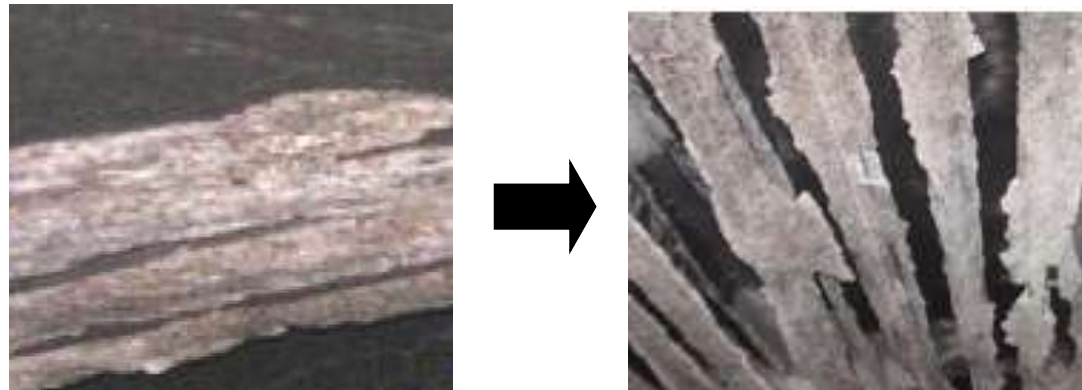
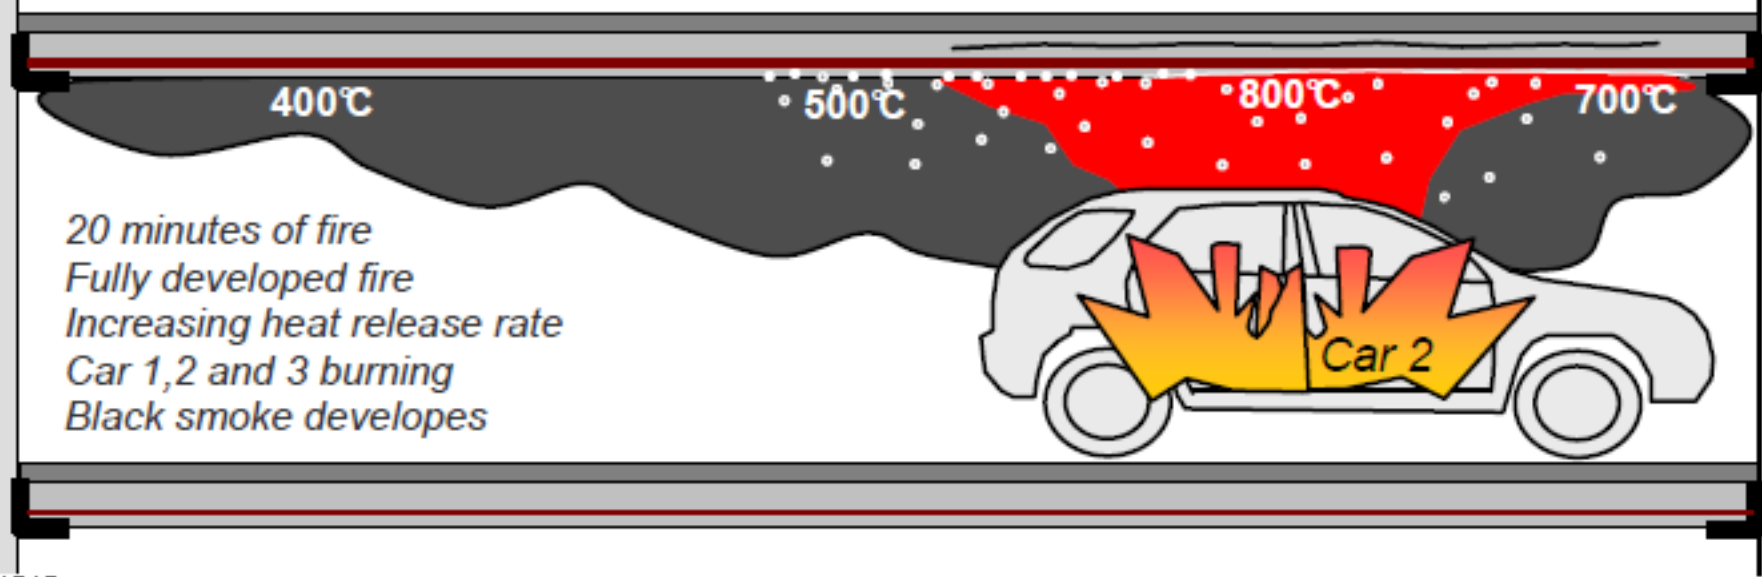
# Phase b) Rotterdam slab #9

Explosive spalling continues over larger slab area and open cores are visible in the slab area above the fire. Horizontal cracks initiate in webs due to intense fire and restraints

20 minutes of fire  
Fully developed fire  
Increasing heat release rate  
Car 1,2 and 3 burning  
Black smoke develops

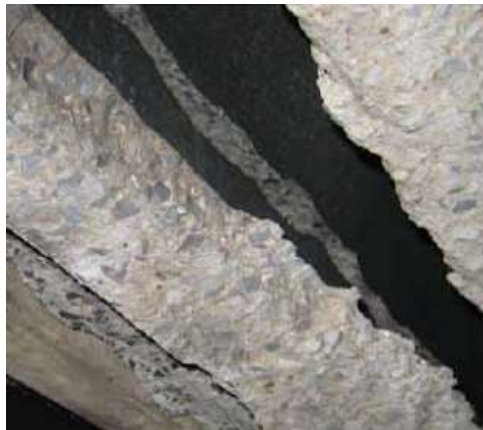
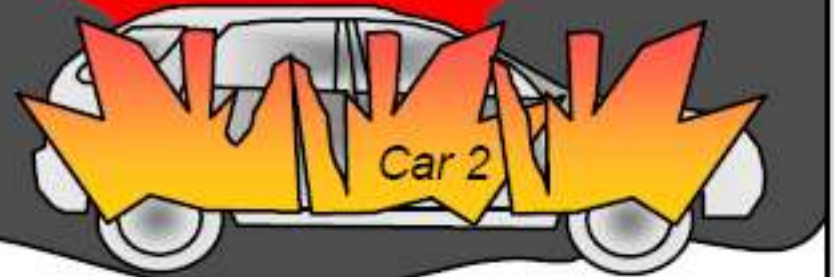
# Phase c) Rotterdam slab #9

With travelling of fire heat front horizontal cracks in webs initiate away from the fire

27 minutes of fire  
Fully developed fire  
Maximum heat release rate  
Cars 1 to 5 burning, car 2 maximum HRR  
Black smoke fills compartment

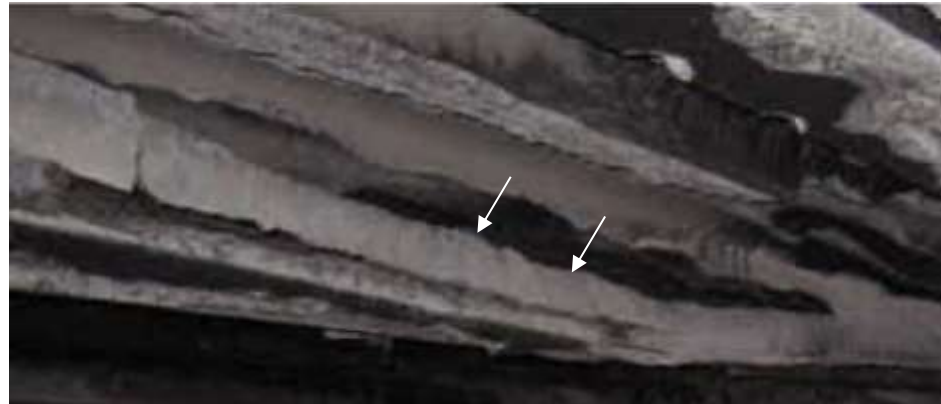
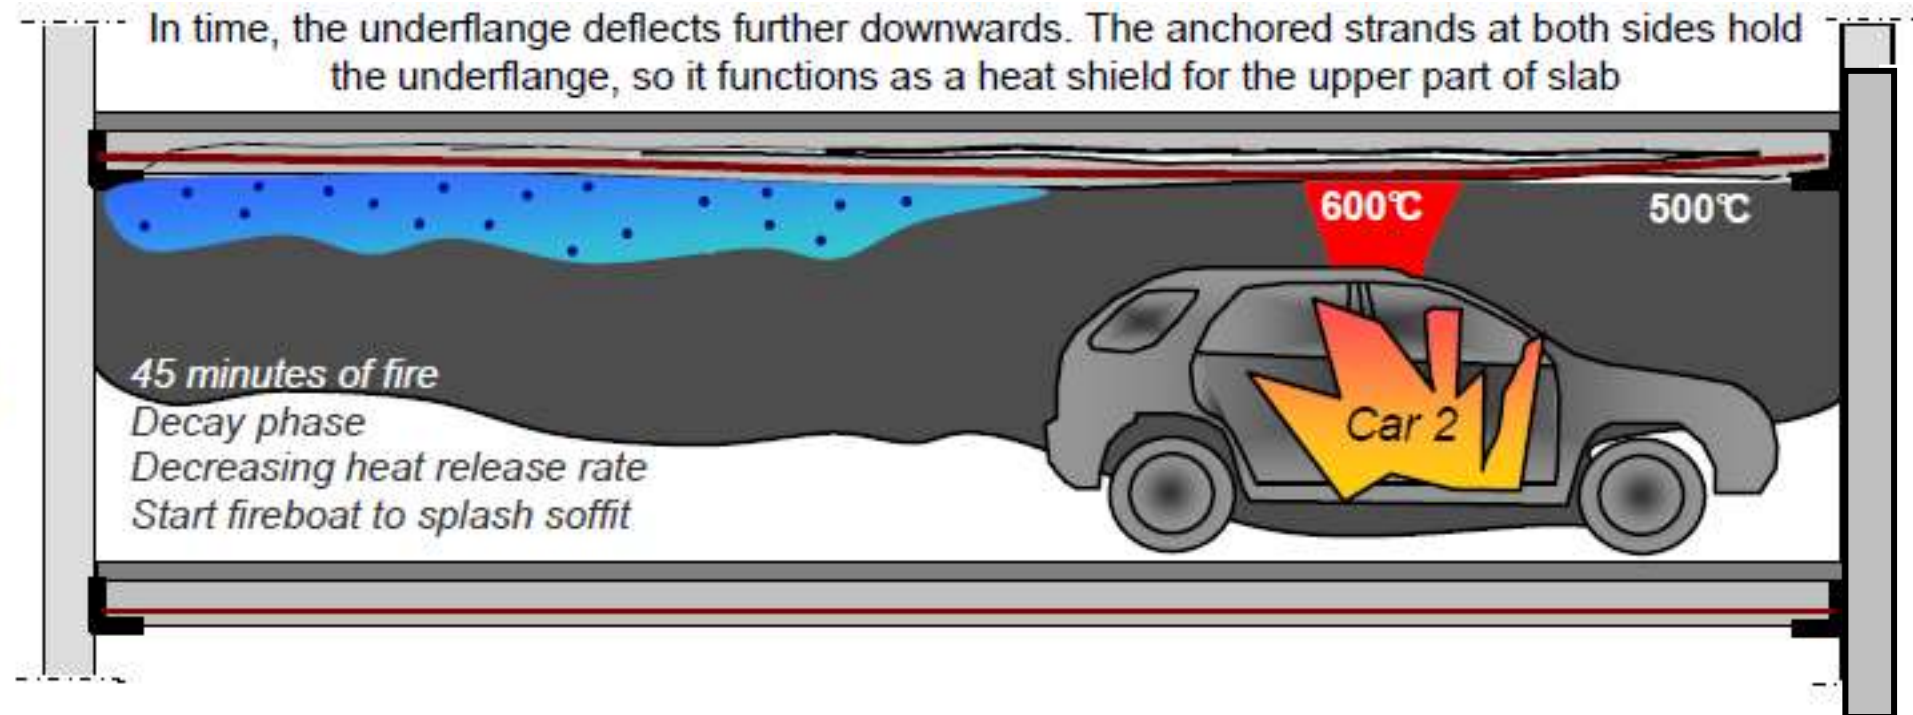
# Phase d) Rotterdam slab #9

In time, the underflange deflects further downwards. The anchored strands at both sides hold the underflange, so it functions as a heat shield for the upper part of slab

45 minutes of fire  
Decay phase  
Decreasing heat release rate  
Start fireboat to splash soffit

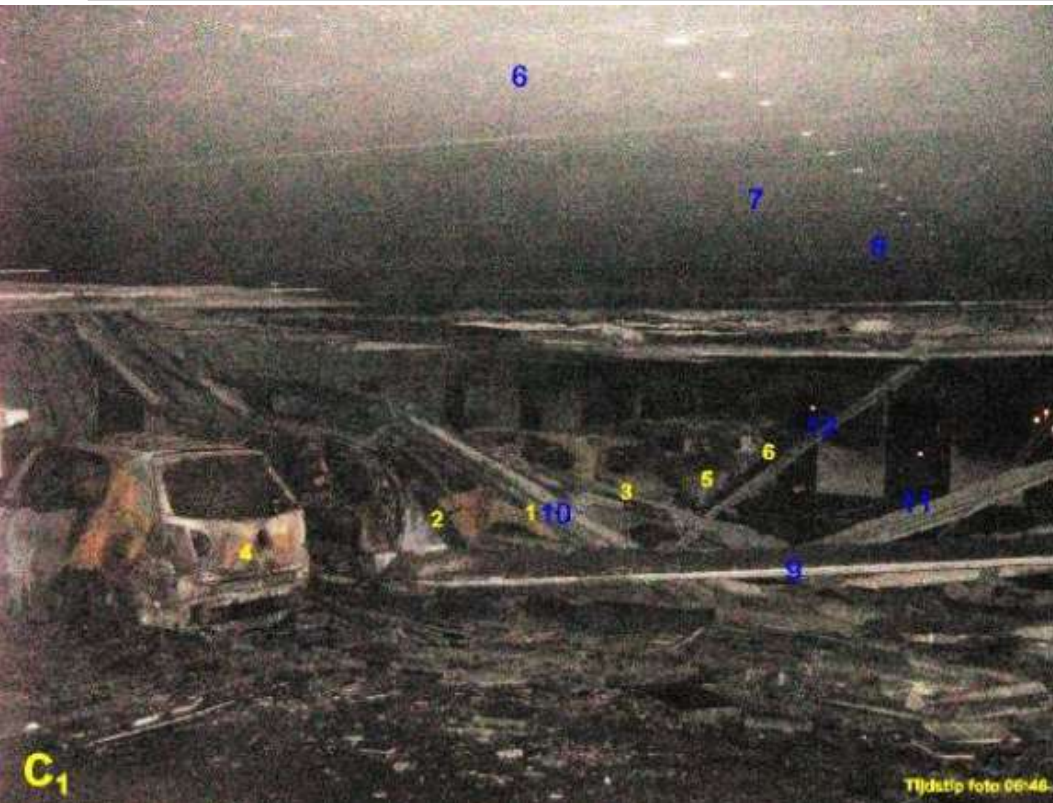
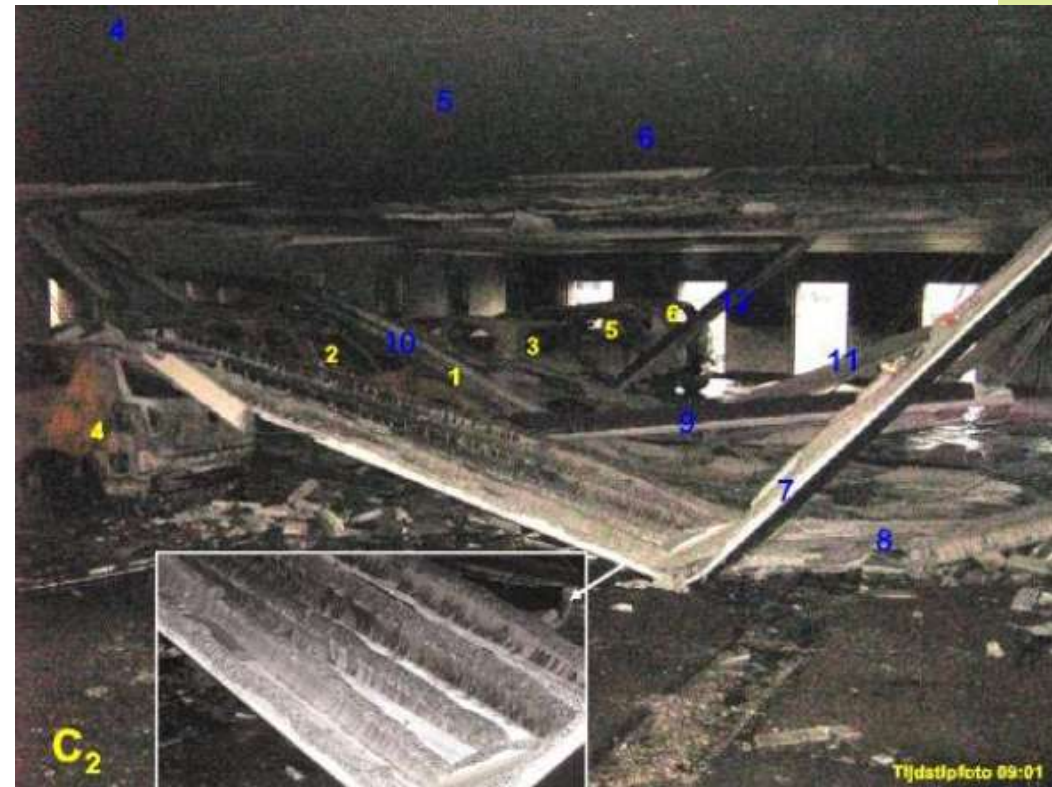
# Slab #7

- Soffits of slabs #9, #10, #11, and part #12 felt down during or just after the fire (first photos are taken at 06.46 h)
- But ....
- Soffits of slabs #7 and #8 felt down several hours later

- Failure of anchorage led to falling down of underflanges
- although the horizontal cracks are there ..
- as long as the strands are well anchored into the support ....
- the underflanges will not fall down ...
- And the slabs will keep their load bearing function

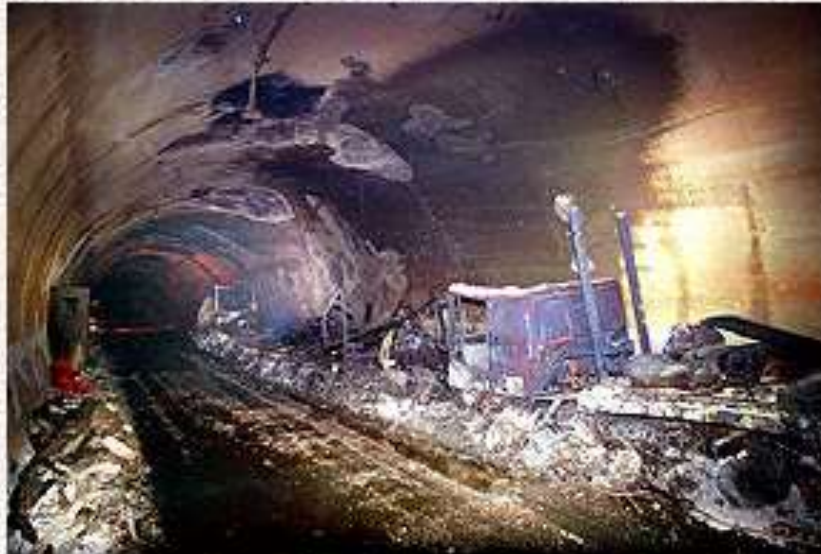
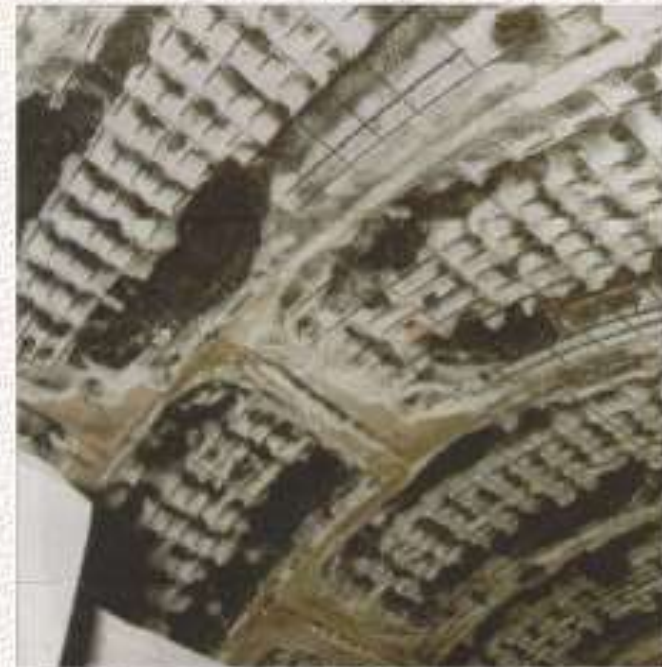
· *Two examples of fire spalling of concrete: (left) the Mont Blanc tunnel and (right) the Channel Tunnel after the fire. The damage to the concrete is clearly visible.*
