**INTERNATIONAL PRESTRESSED HOLLOW CORE ASSOCIATION**

## **SAFETY ISSUES ON SITE**

IPHA Technical Seminar

Safety Issues on Site

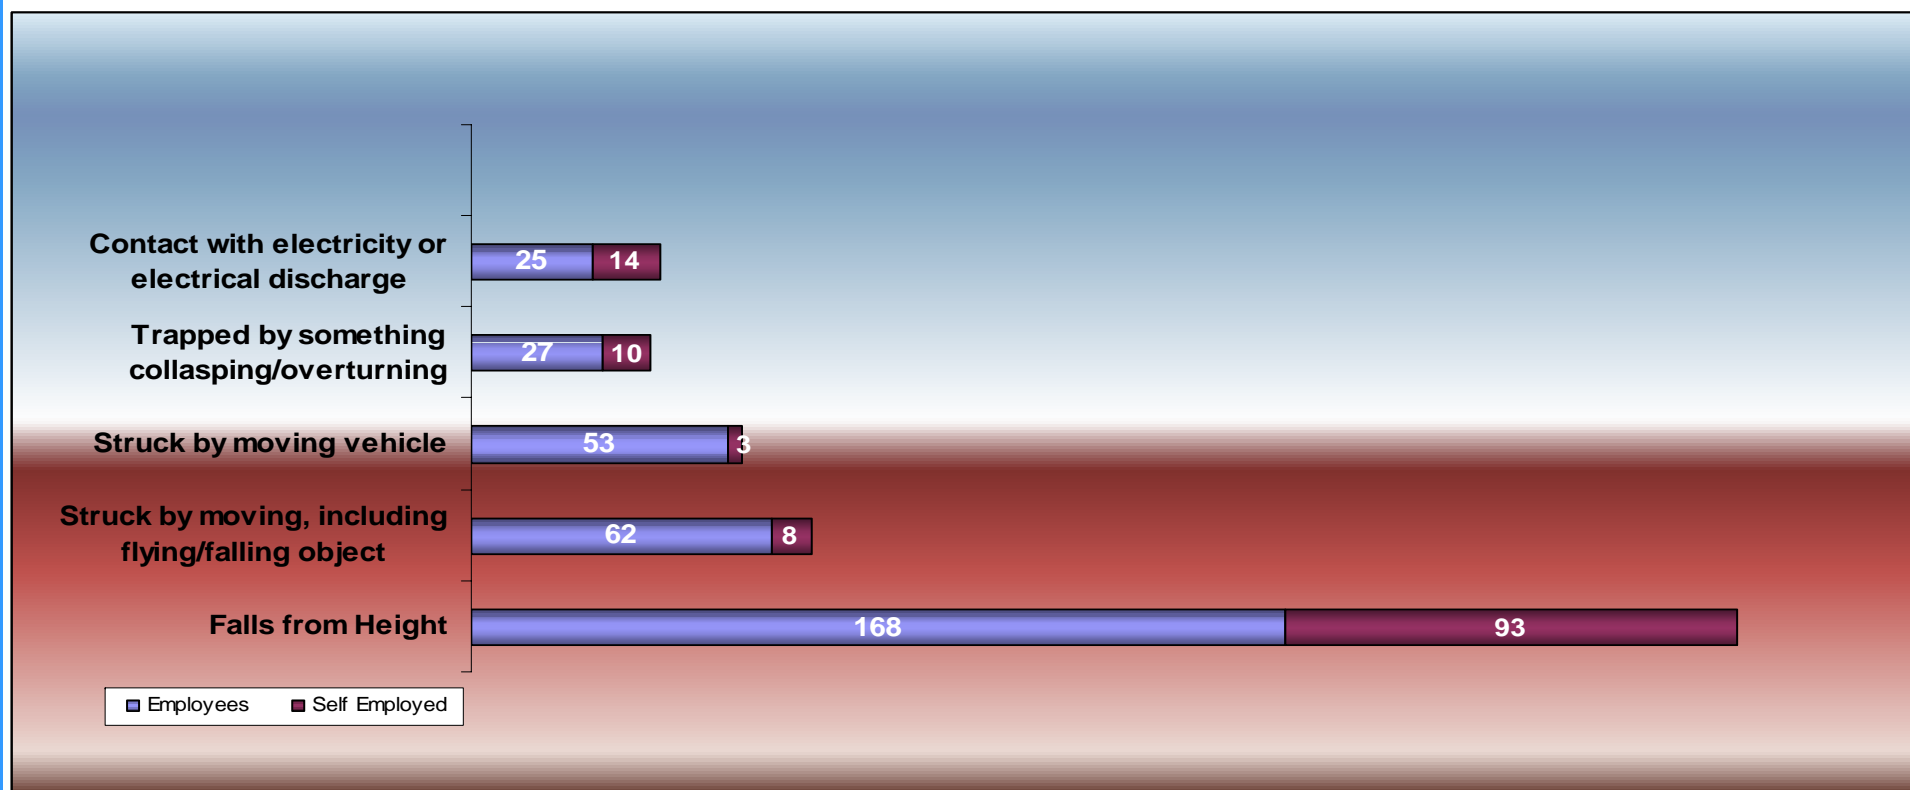
### Number of fatal injuries to workers in Construction by kind 1996/7 - 2001/02p

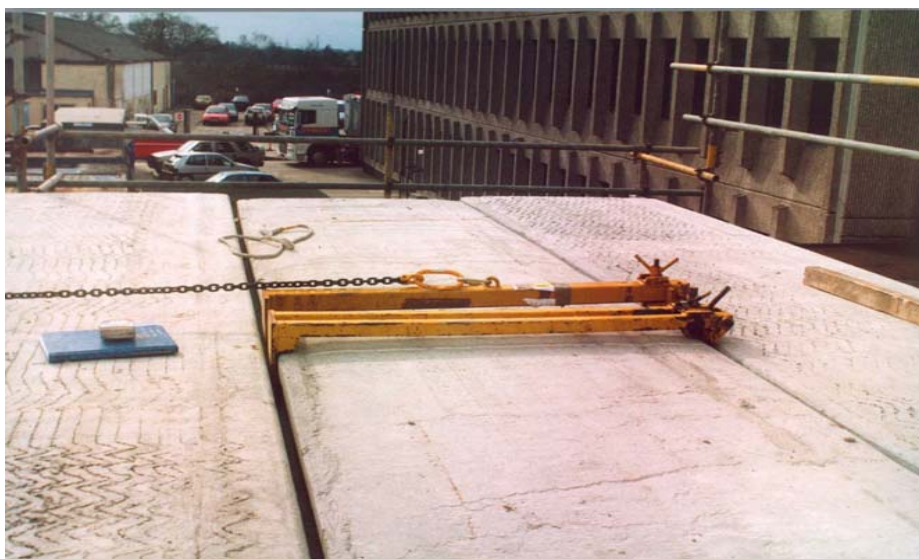
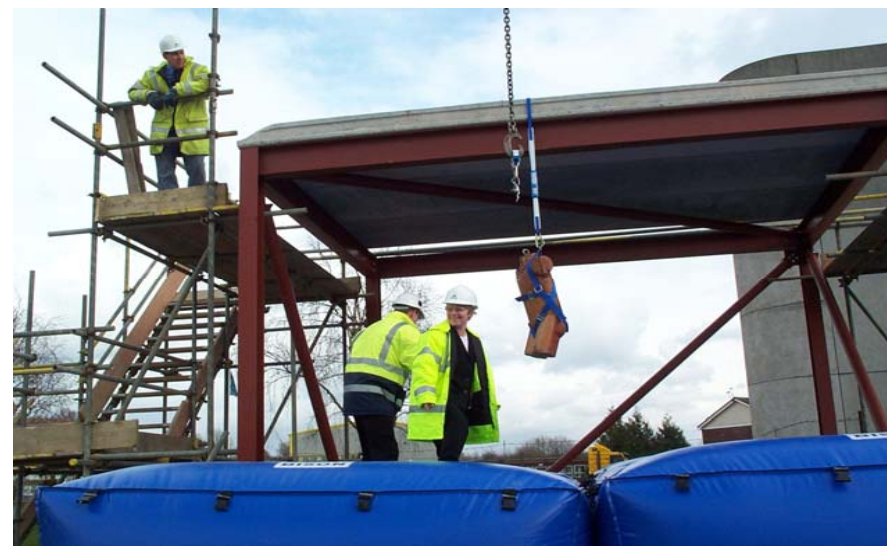
Active fall protection system

- Safe working platform, with guard rails and toe boards
- Passive fall arrest system
- Active work restraint system
- Active fall arrest system

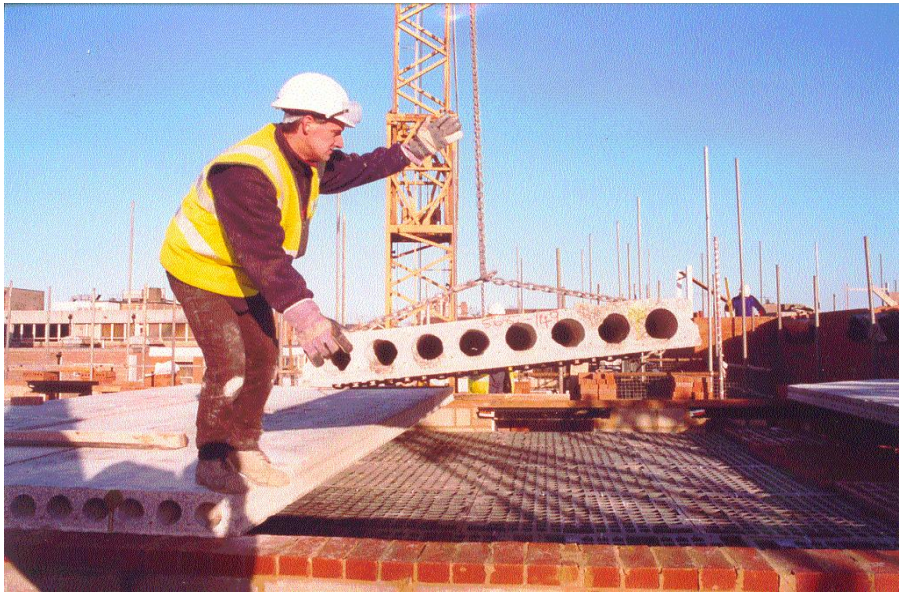
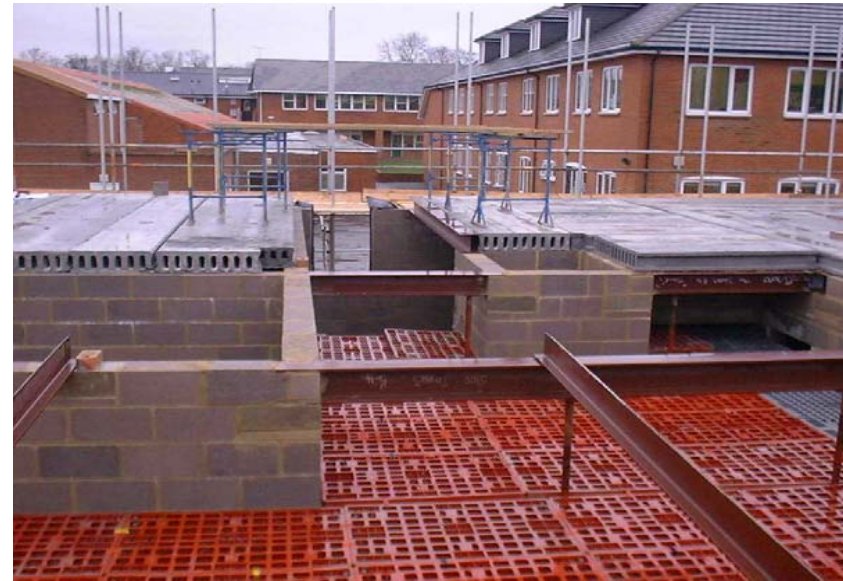
Safety Decking

A lightweight plastic platform system supported on plastic props.

- Can be used as a temporary working platform
- Usually installed the day before the erection.
- Highly visible.

- All blockwork must be erected at least 48 hours prior to erection to provide lateral stability to the system.
- Transportation of the rigid plastic components
- Requires walls to retain the system.
- Floor area must be firm and level
- Extends time on site.

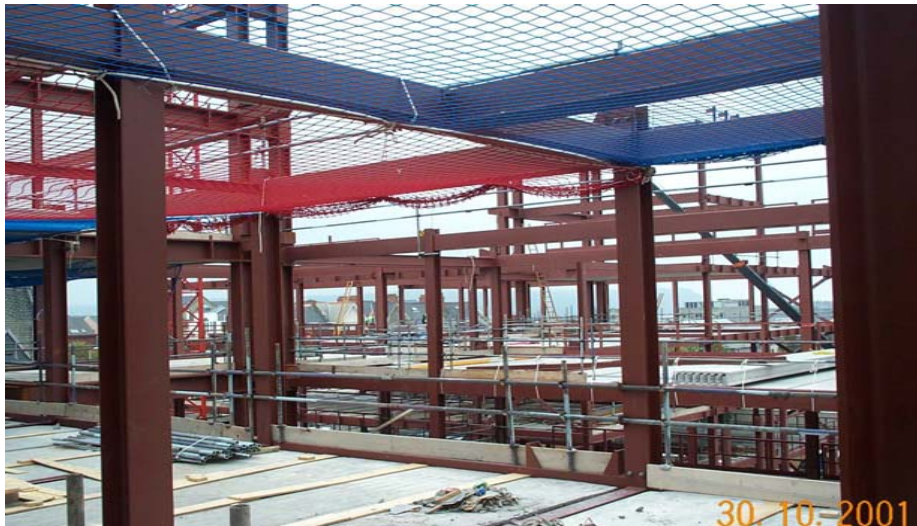
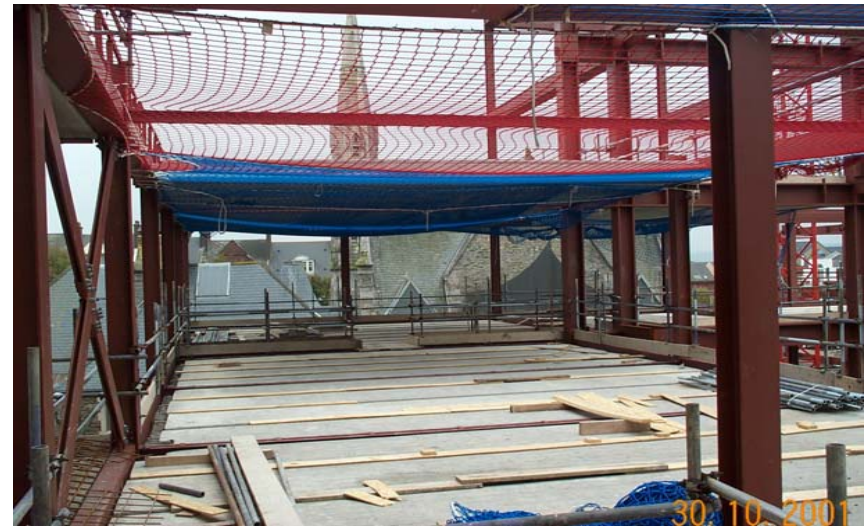
## Safety Netting

- Erected immediately below the working area
- Large area can be protected
- Can be erected up to 6m above floor level

- Needs rescue/ retrieval method
- Subject to UV damage
- Chains snag in net
- Installed the day before, removed the day after floor installation

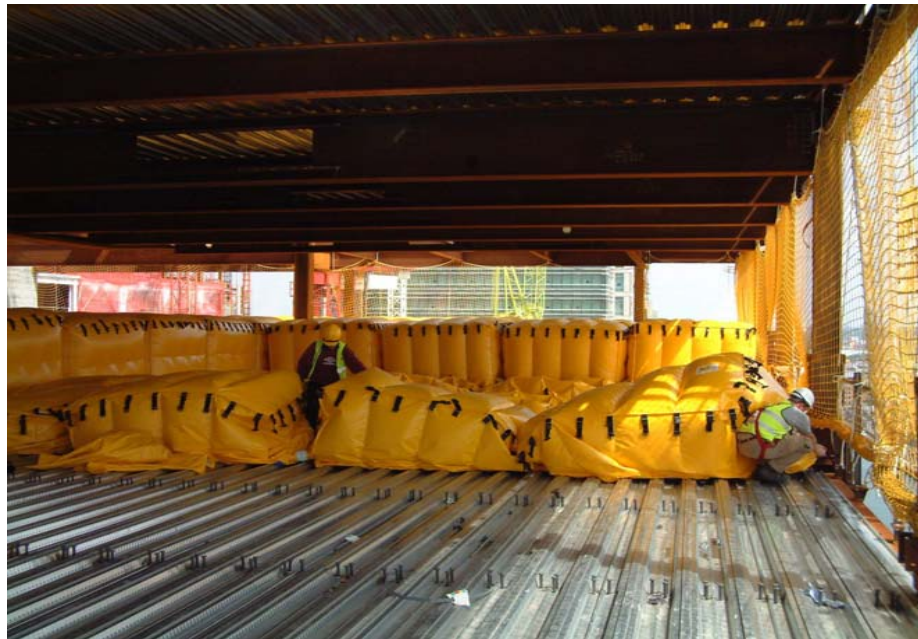
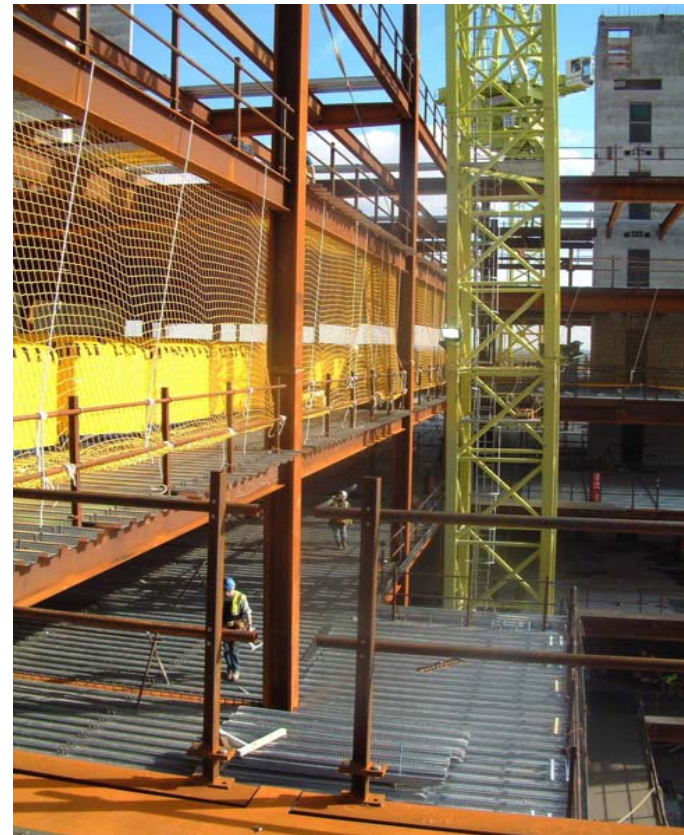
AirMat's with side netting

- Quick and easy to install and de-install on day of erection
- Can be carried and erected by the installation gang
- Totally flexible/adaptable to any internal configuration

- If wrong size mats are selected damage can be caused to the blockwork structure
- Air pumps can run out of fuel
- Unsuitable for uneven ground with projections

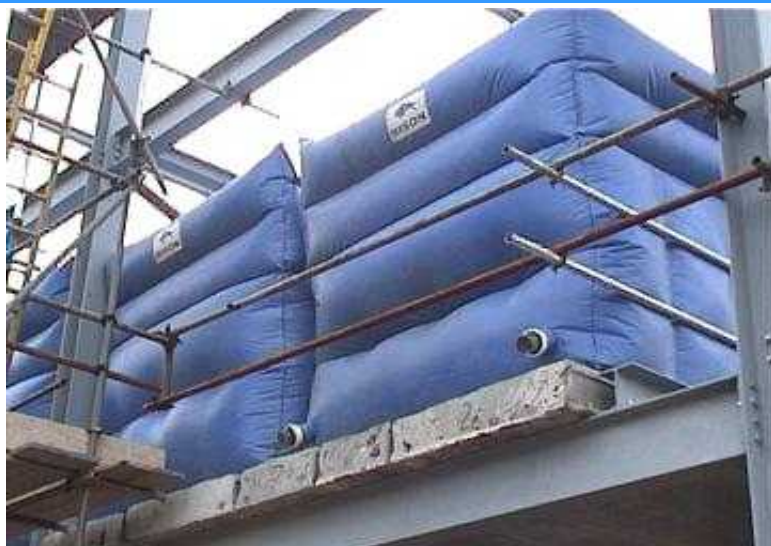
● Parapet bags

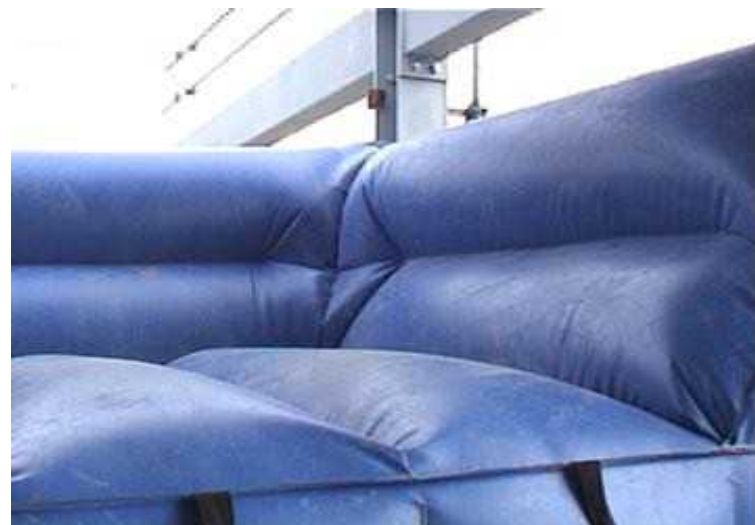
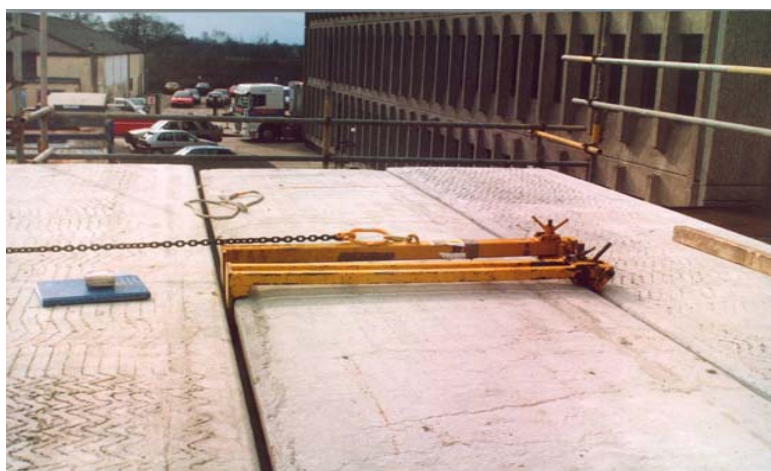
● Harness & Clamps

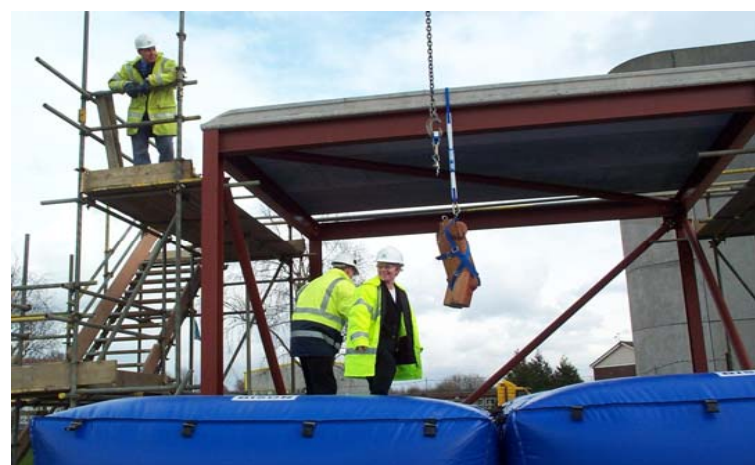
● Validation Testing
