HOLCOFIRE

Behaviour of prestressed
hollowcore floors exposed to fire

Database with 162 fire test results

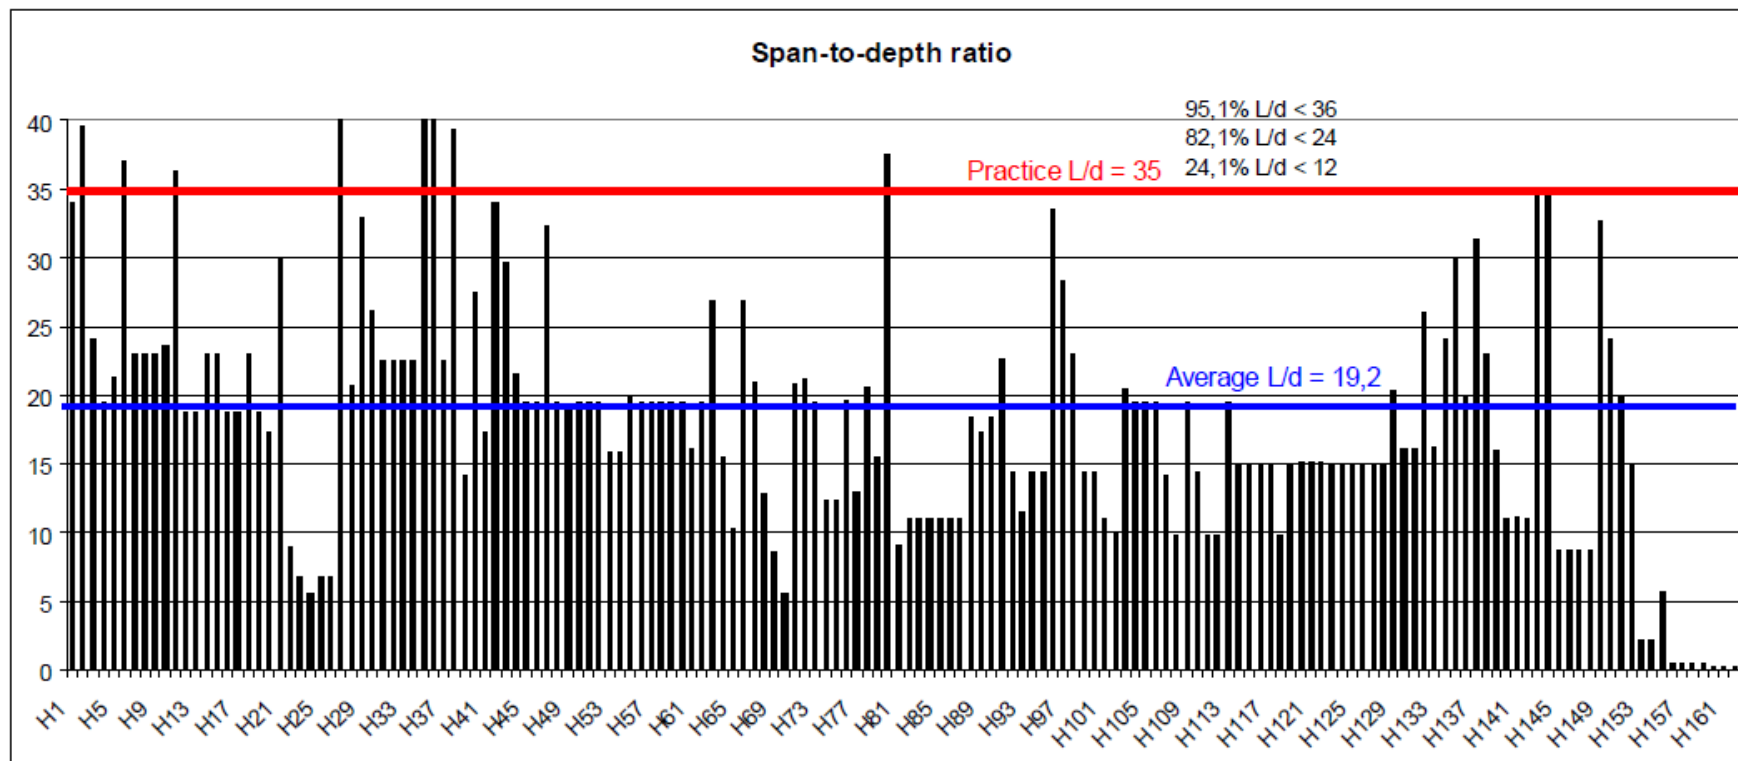
- The ideal span-to-depth ratio in practice is 35
- The average span-to-depth ratio in fire tests is 19,2
- Furnaces available 4m x 6m

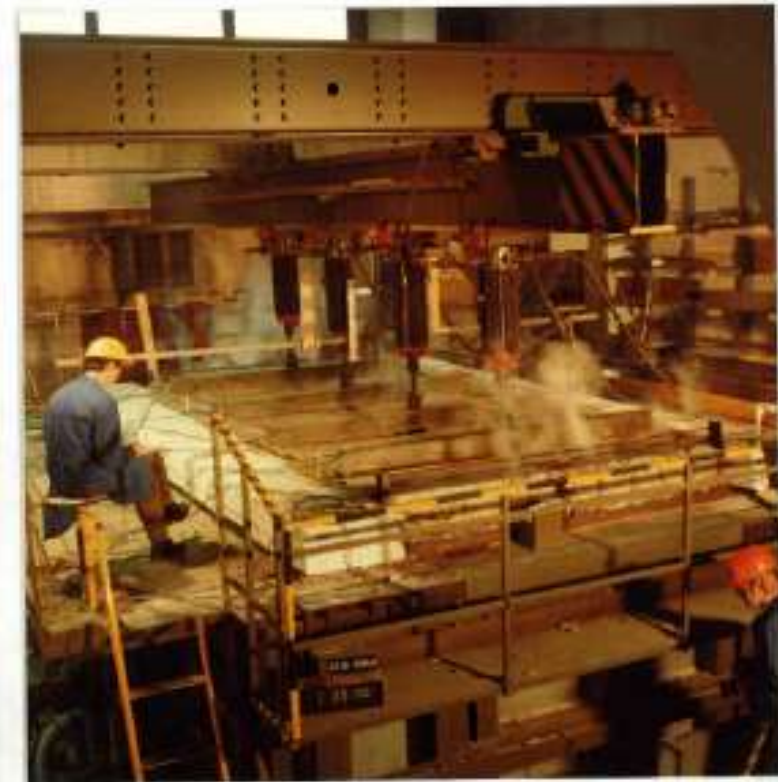
Bending moment / bending capacity fire

- In 96 tests bending moment / capacity < 100%
- Only 6 tests > 100%, but 3 of these did not fail

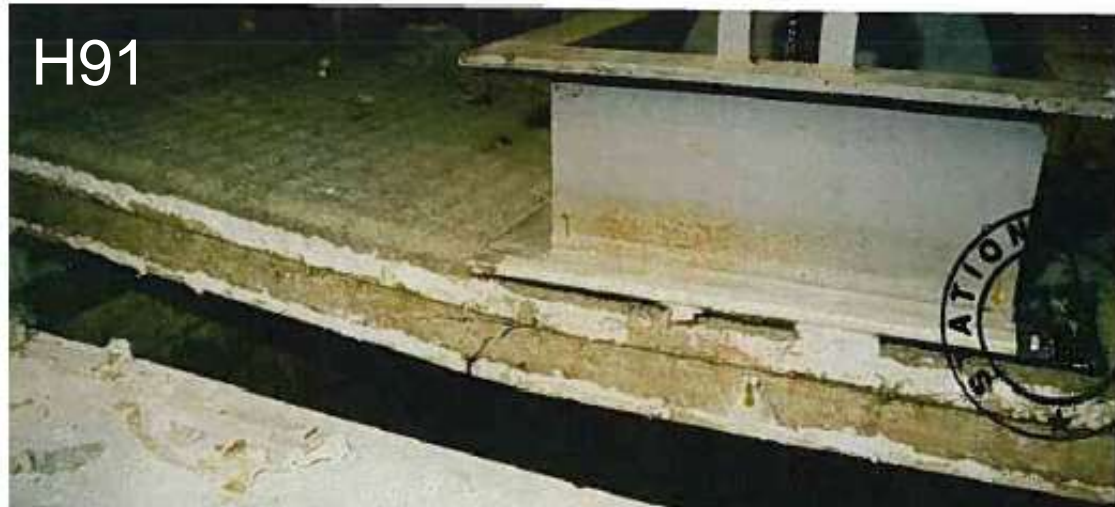
H20: 0.95
H80: 1.38
H88: 1.15
H90: 1,56
H91: 1,13
H113: 1.33

$$\frac{V_S}{V_{R,fi}} + \frac{M_S}{M_{R,fi}} + \frac{T_S}{T_{R,fi}} \leq 1.0$$

- “For this failure mode, which can be regarded to be in the transition range between flexural-shear and anchorage failure only 6 relevant tests could be found. Actually this requires the statistical uncertainty to be taken into account. An interaction formula is given, showing a mean value and standard deviation which are fair enough. It might be wondered if this is really needed, since the lowest bearing resistance obtained from the separate equations for bending and shear may be expected to give a reasonable design value as well”.

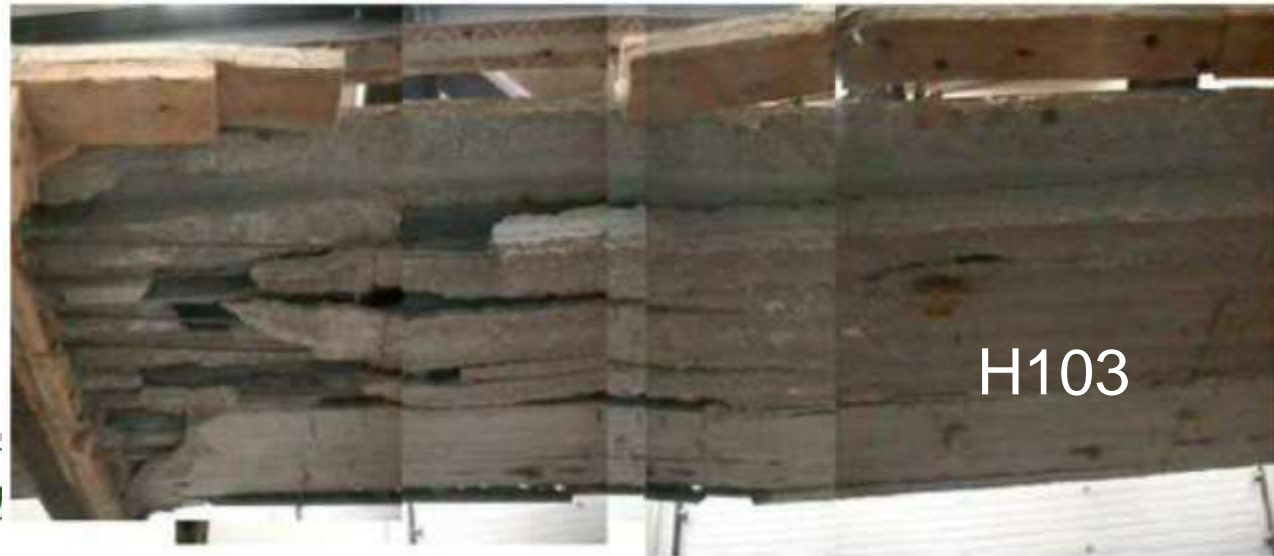
Part of hole that occurred at 39 minutes

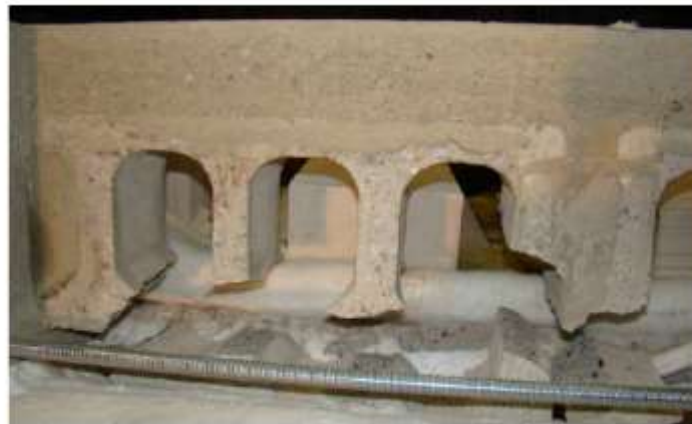
Specific Dutch tests on slices
