INTERNATIONAL PRESTRESSED  
HOLLOWCORE ASSOCIATION

## ***HOLCOFIRE***

Behaviour of prestressed  
hollowcore floors exposed to fire

*Spalling and horizontal cracking*

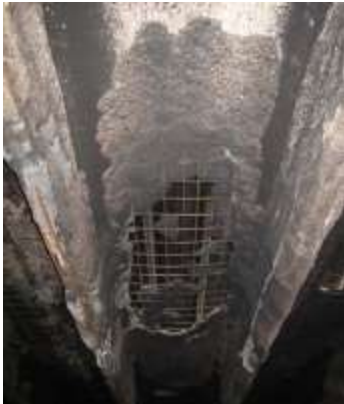
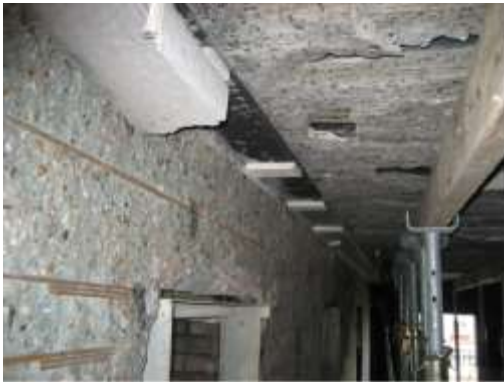
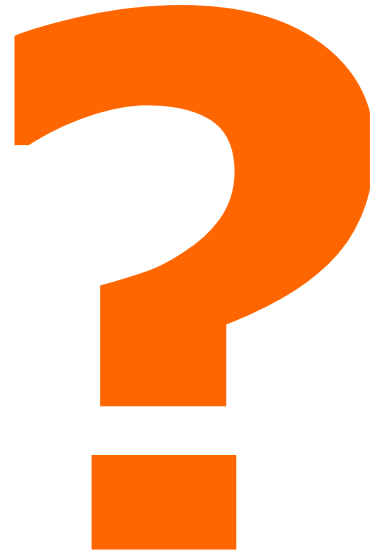
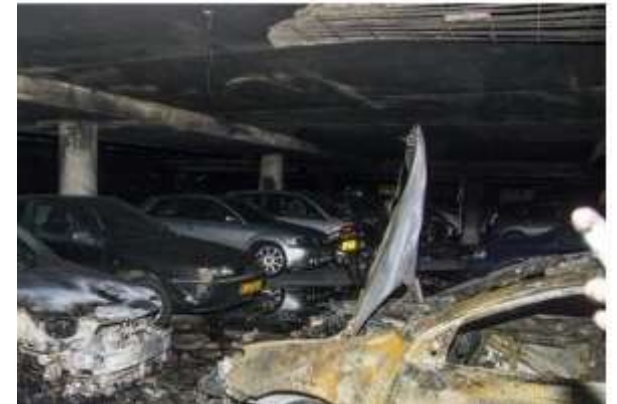
## *Spalling and horizontal cracking*

**hollow core phenomena  
or  
concrete phenomena**

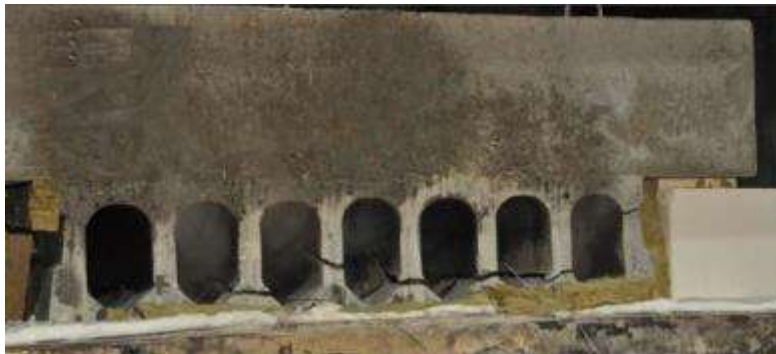
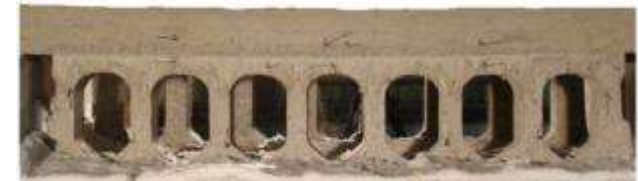
Fire tests on small samples of hollow core slabs

By prof. ir. D. Hordijk (in cooperation with BFBN)

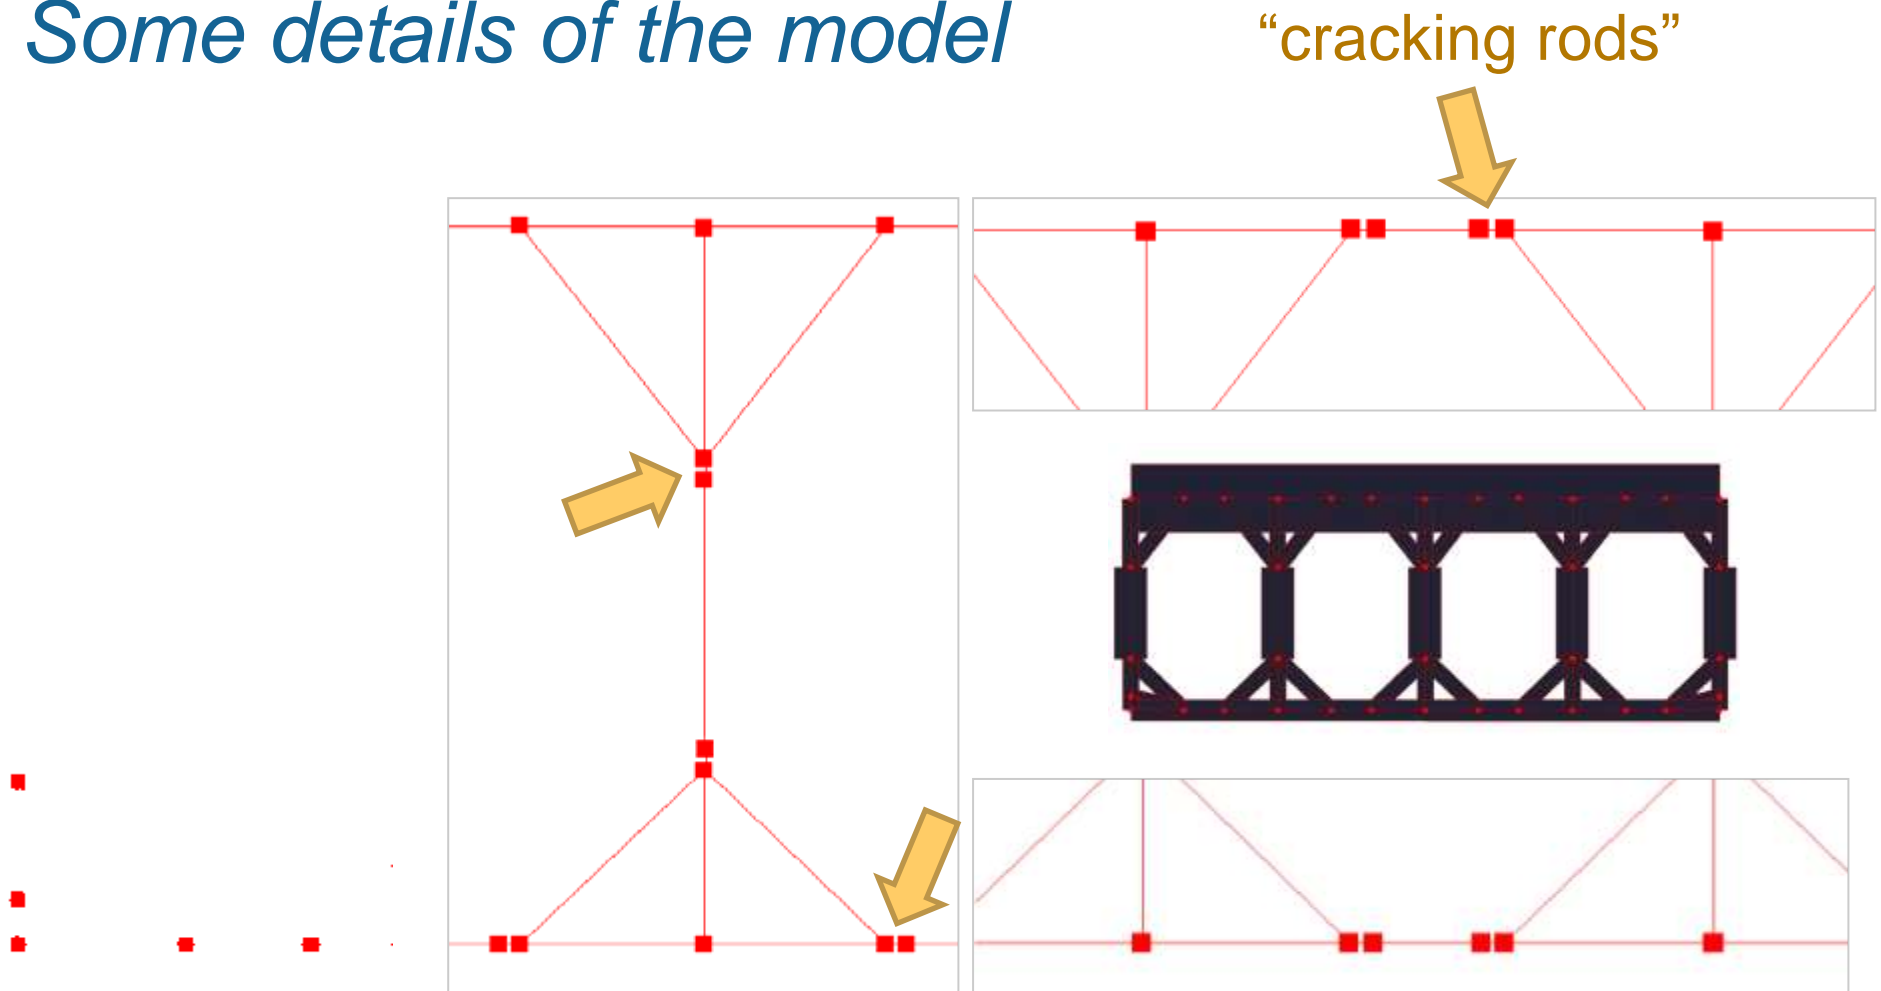
## *Some details of the model*

- Semi-non-elastic behaviour through predefined cracked rod positions,  
When a rod cracks:
  - Under compression: introduce a hinge
  - Under tension: no connection (nodes can move; crack can open)
- The stiffness of the under flange is temperature/time dependent
- Modelling of floorfield action through:  
Blocking spring and optional free space (joint or shrinkage cracks)
- Compression failure of under flange is checked. (spalling)

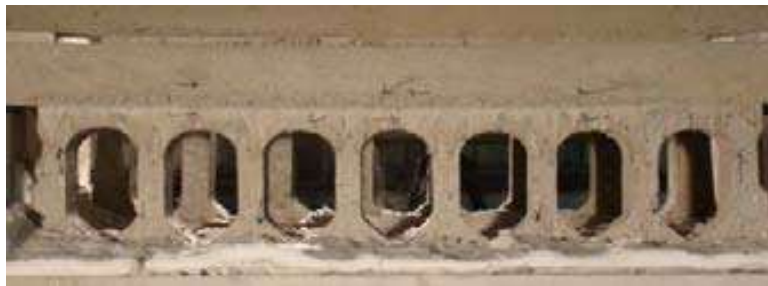
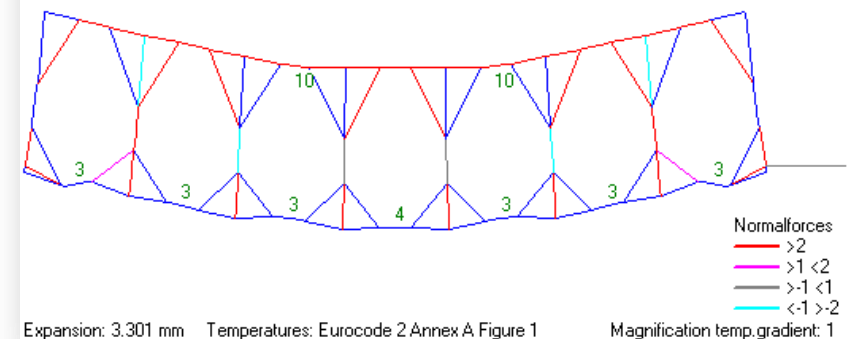
## Comparison with test result

HC260 + 100 mm topping

260/7 b=1200 fck=45 bw=320/40/0 TF=35 UF=45 CW=72 CF=0.3 YHB=33  
FE = 30 minutes TOPPING = 100 mm BLOCKING = 0 N/mm CLEAR SPACE = 0.45 mm

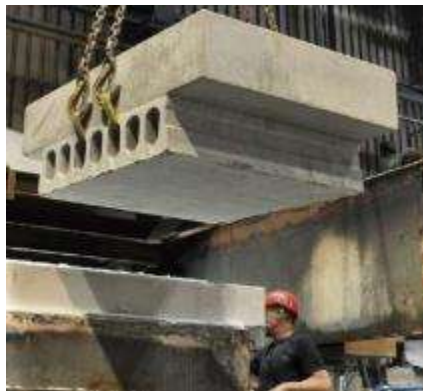
260/7 b=1200 fck=45 bw=320/40/0 TF=35 UF=45 CW=80 CF=0.3 YHB=33  
FE = 30 minutes TOPPING = 300 mm BLOCKING = 0 N/mm CLEAR SPACE = 0.45 mm

No energy or dynamic effects are taken into account in the model!

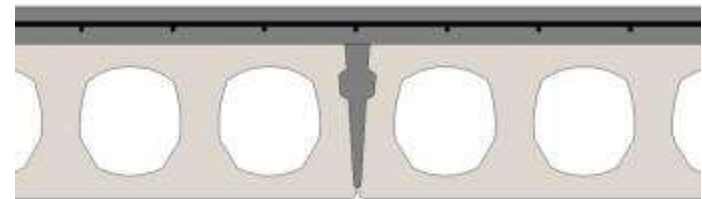
Reinforced structural topping or tying reinforcement:

**Order of size of the blocking spring:**

Assume concrete to be cracked:

The magnitude is governed by the amount of reinforcement:

2 beams:  $A_s = 1360 \text{ mm}^2$

Topping:  $A_s = 1360 \text{ mm}^2$

$K_{\text{reinf}} = A_s \cdot E_s / L_{\text{system}} = 4.5 \cdot 10^5$

Average k-value over the length of joint:

$4.5 \cdot 10^5 / 5300 = 85 \text{ N/mm}$

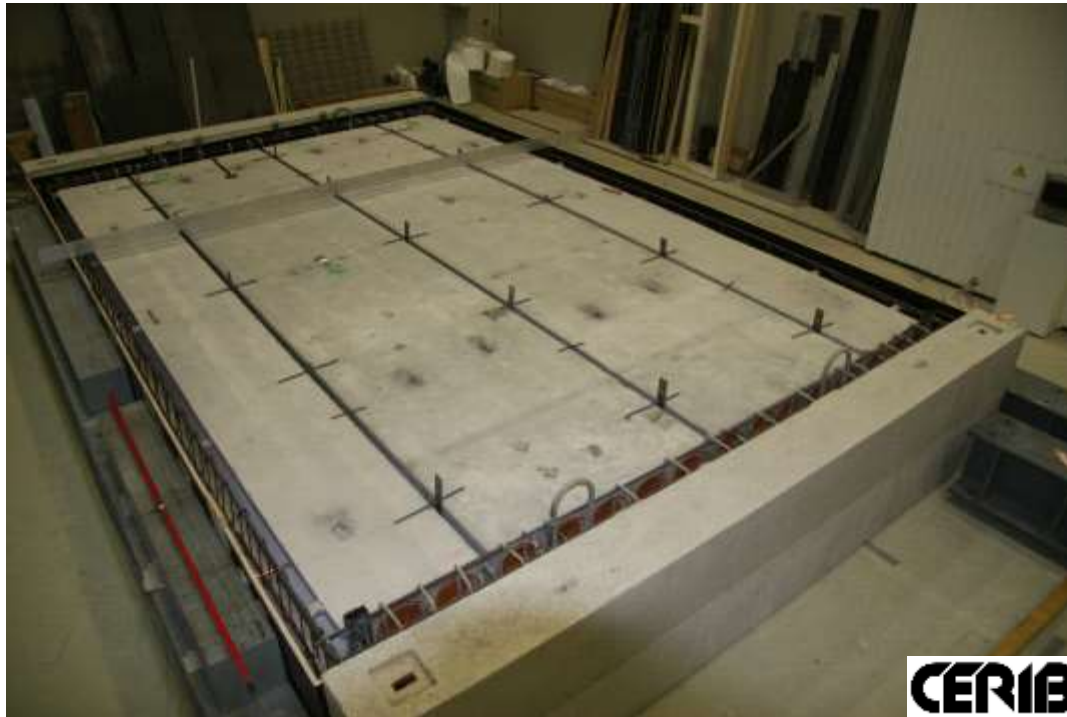
- Peripheral tie beam around the floor
- Precast support beam b x h = 300x400 mm<sup>2</sup>
- Hollow core depths 255, 260, 200 and 265 mm
- Toppings of 100, 100, 50/70 mm and without topping.

Span the furnace in long direction (one test span in short direction)

5.90 m length

3.90 m width

2 full slabs, 2 fitting slabs (one test: 4 full slabs)

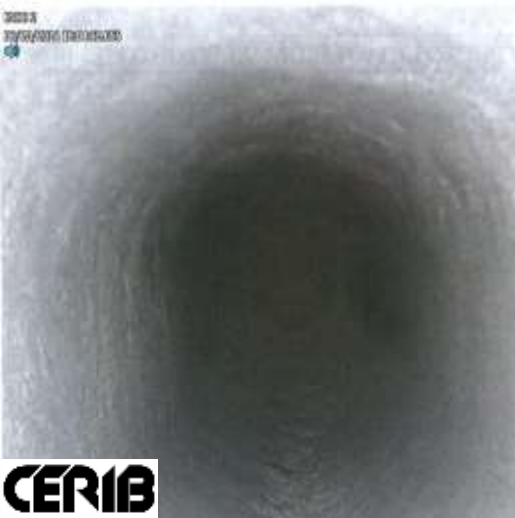
G2 - 16 minutes

- Innovative core camera in core in fire test developed at Cerib registered vertical cracking according to theory

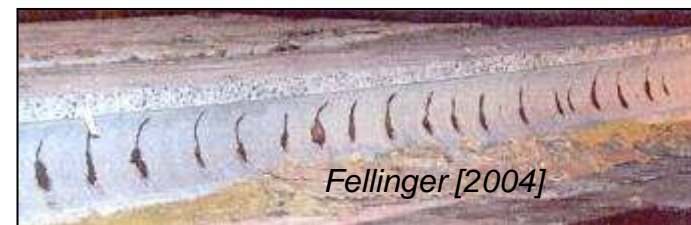
G2 - 46 minutes

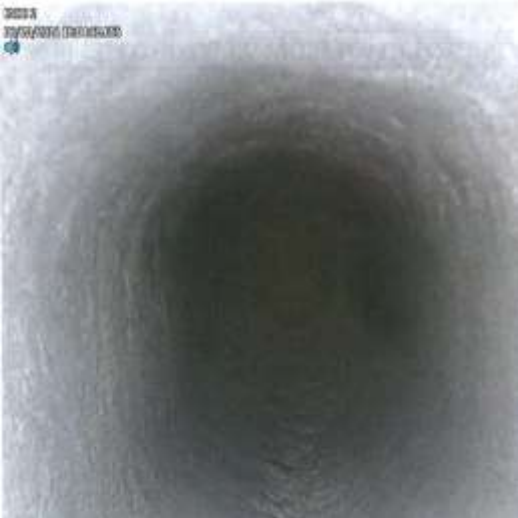
# R2 camera in core, at 16'

G2 - 16 minutes

- 260 mm with 100 mm topping
- $F = 30$  kN on floor ( $G = 6.4$  kN/m<sup>2</sup>,  $q=1.4$  kN/m<sup>2</sup>)
- Horizontal cracking between 16' and 19'
- In combination with spalling at soffit
- Test continued, fire stopped at 91' (REI90)
- Loaded up to bending failure at 291 kN

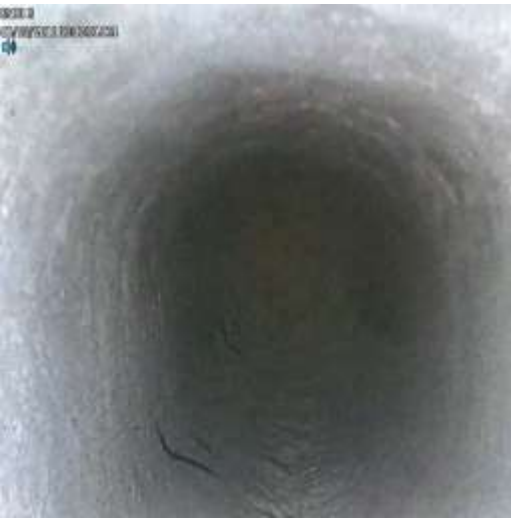
# R2 camera in core, at 17'

G2 - 18 minutes

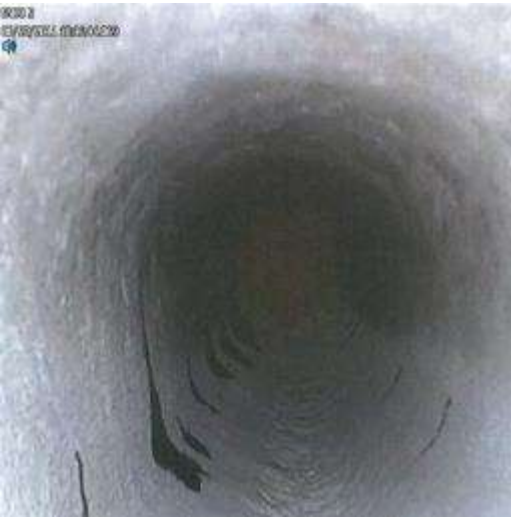
# R2 camera in core, at 21'

G2 - 23 minutes

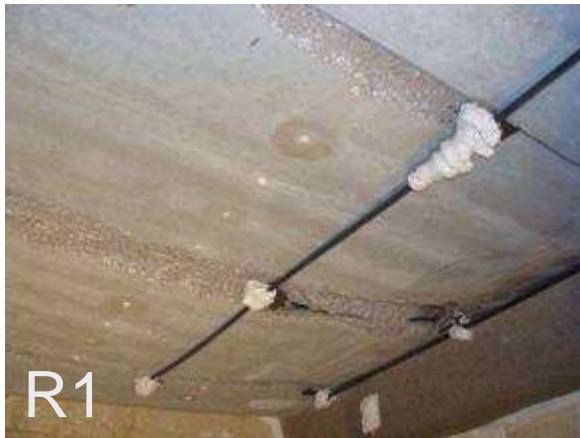
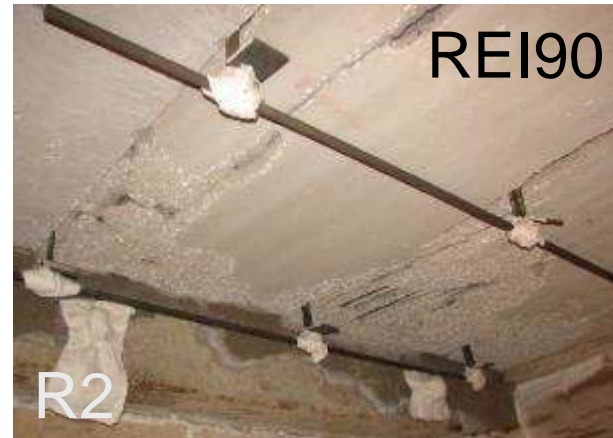
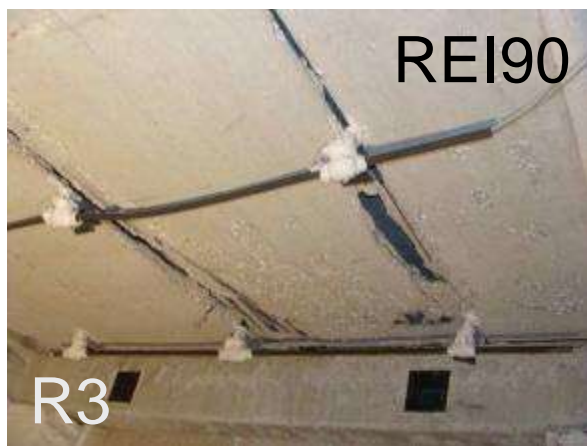
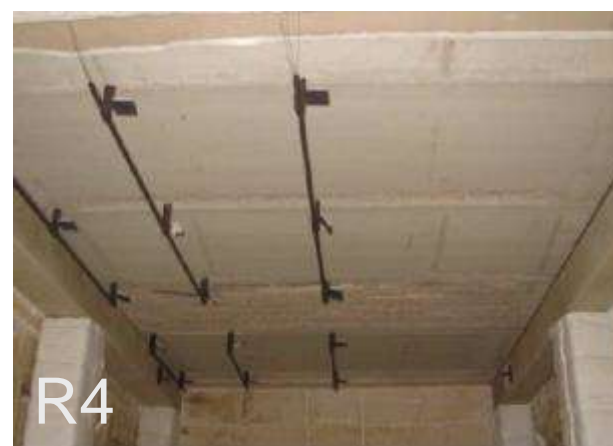
*Fire tests R1,R2,R3,R4 soffit after execution:*

- **R1: 255 mm with 100 mm topping**
  - $F = 280 \text{ kN}$  ( $G=6.3 \text{ kN/m}^2$ ,  $q= 13 \text{ kN/m}^2$ )
  - Horizontal cracking or horizontal shear crack at 13'
  - Shear flexural failure at 37' as load was high
- **R2: 260 mm with 100 mm topping**
  - $F = 30 \text{ kN}$  on floor ( $G=6.3 \text{ kN/m}^2$ ,  $q =1.4 \text{ kN/m}^2$ )
  - Horizontal cracking between 16' and 19'
  - In combination with spalling at soffit
  - Test continued, fire stopped at 91' (REI90 granted)
  - Loaded up to bending failure at 291 kN

- $F = 30 \text{ kN}$  ( $G=4.6 \text{ kN/m}^2$ ,  $q=1.4 \text{ kN/m}^2$ )
- Horizontal cracking between 13' and 15'
- In combination with spalling at soffit
- Test continued, fire stopped at 91' (REI90 granted)
- Loaded up to bending failure at  $> 119 \text{ kN}$

- Shear load  $F = 52 \text{ kN/m}$
- After 21' loud bang, test continued
- After 56' test stopped for safety reasons (EI) hole in floor.
- Shear load resistance was still sufficient (R)
- After dismantling the floor there was only one slab with spalling on the soffit and cracked webs

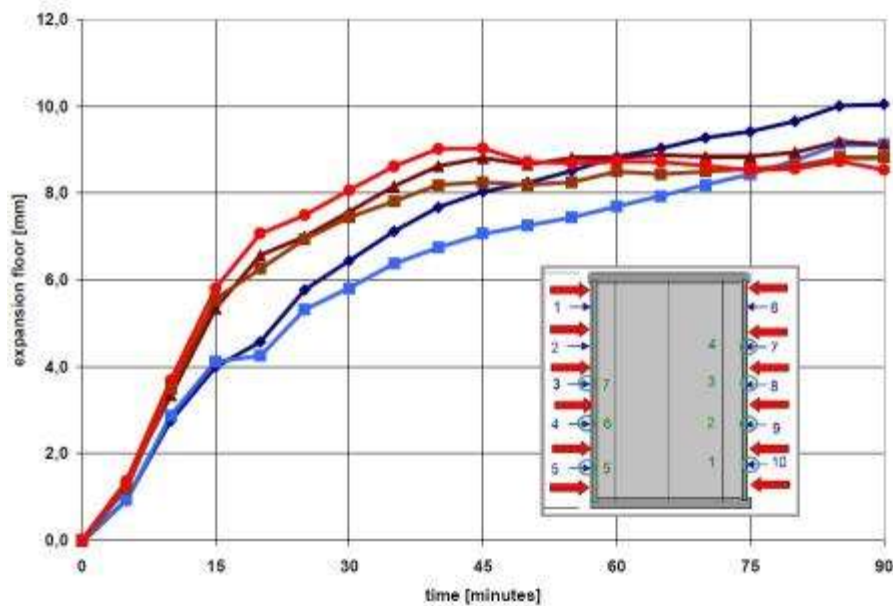
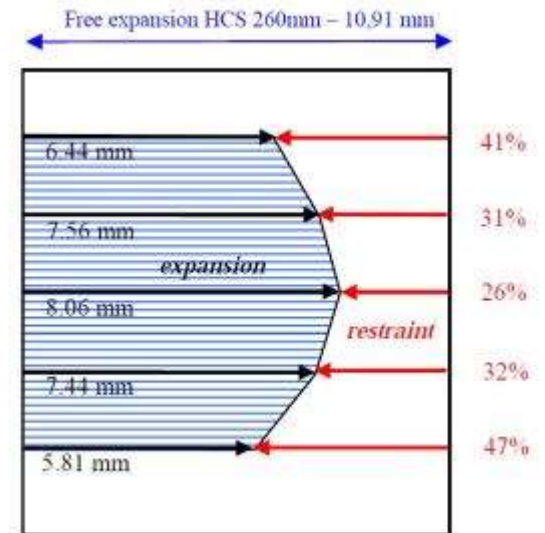
## Test R2 horizontal displacement:

expansion at  
30 minutes

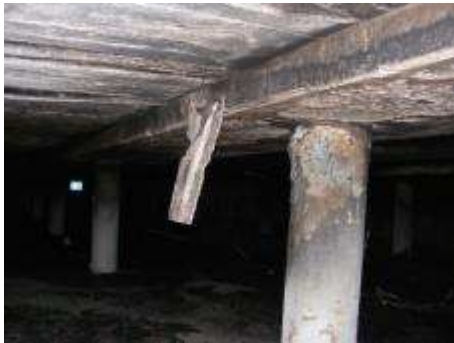
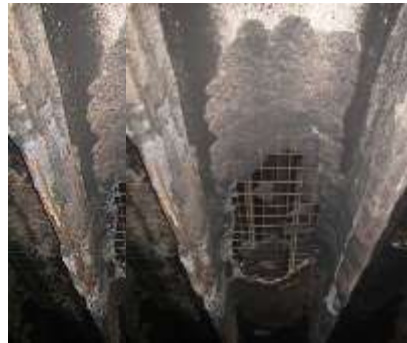
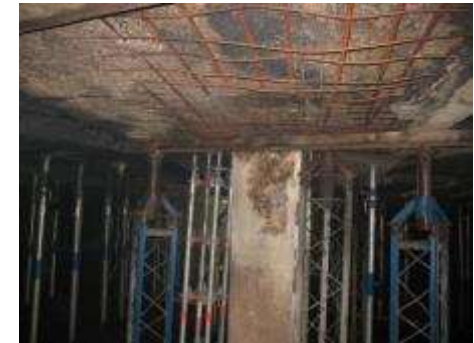
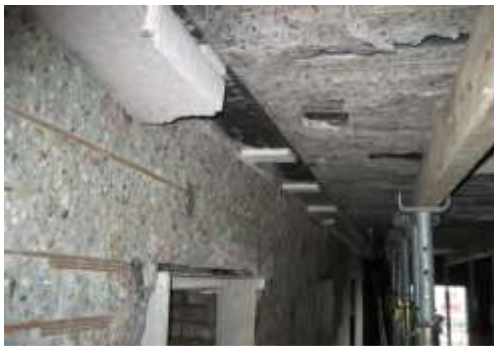
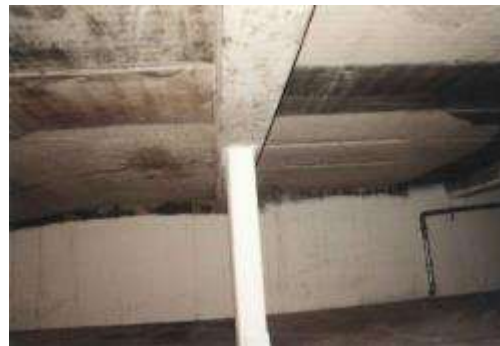
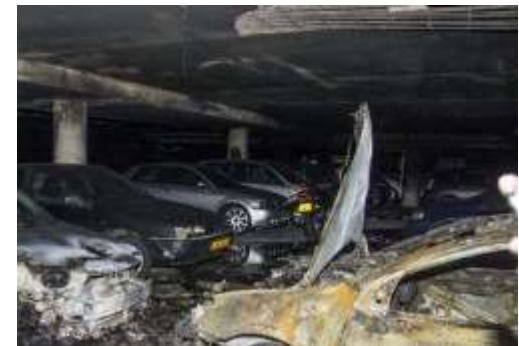
## *Considerations with regard to spalling*

- All concrete (floors) respond similar to fire.

- Blocking is an important parameter for hollow core floors, but this applies for all concrete structures and will cause spalling damage on the soffit.
- Horizontal web cracks can lead to local damage.
- The structure is the cause of restraint; but it also provides the second load path.
- We are out of phase of unconscious incompetence.
- It is not too easy to translate the accidental case of fire into a numerical model.
- It is a myth that concrete structures only need to be cleaned after a serious fire.
