**Full-scale Fire Tests on
Hollowcore Floor System**

Colin Bailey: *University of Manchester*

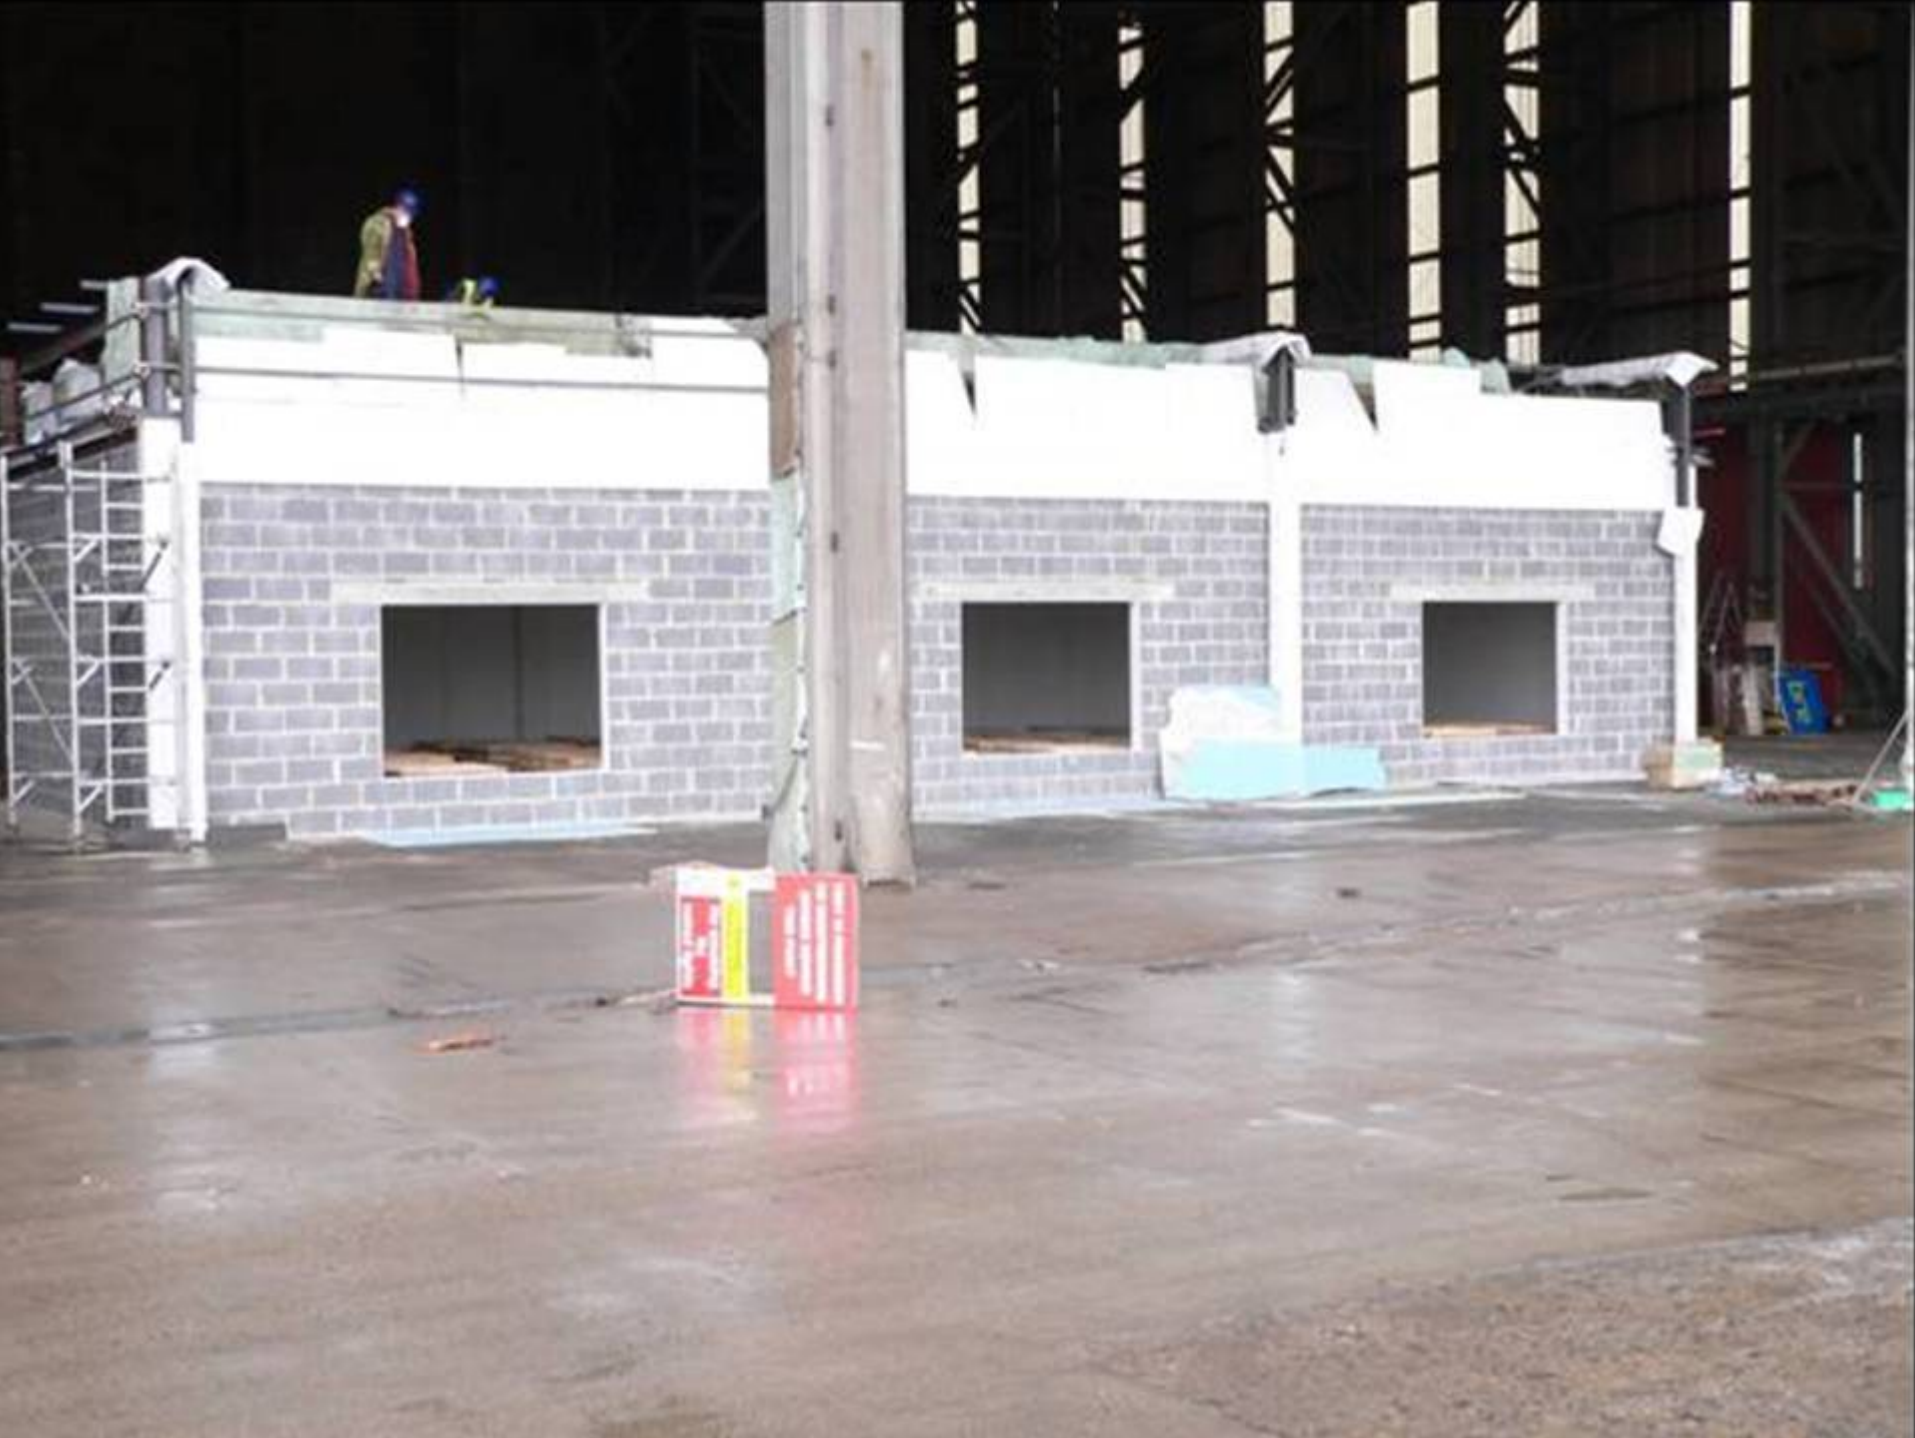
Test Structure: 7.02m×17.76m (internal plan dimensions) ×3.6m height

15 units 1.2m wide×200mm deep

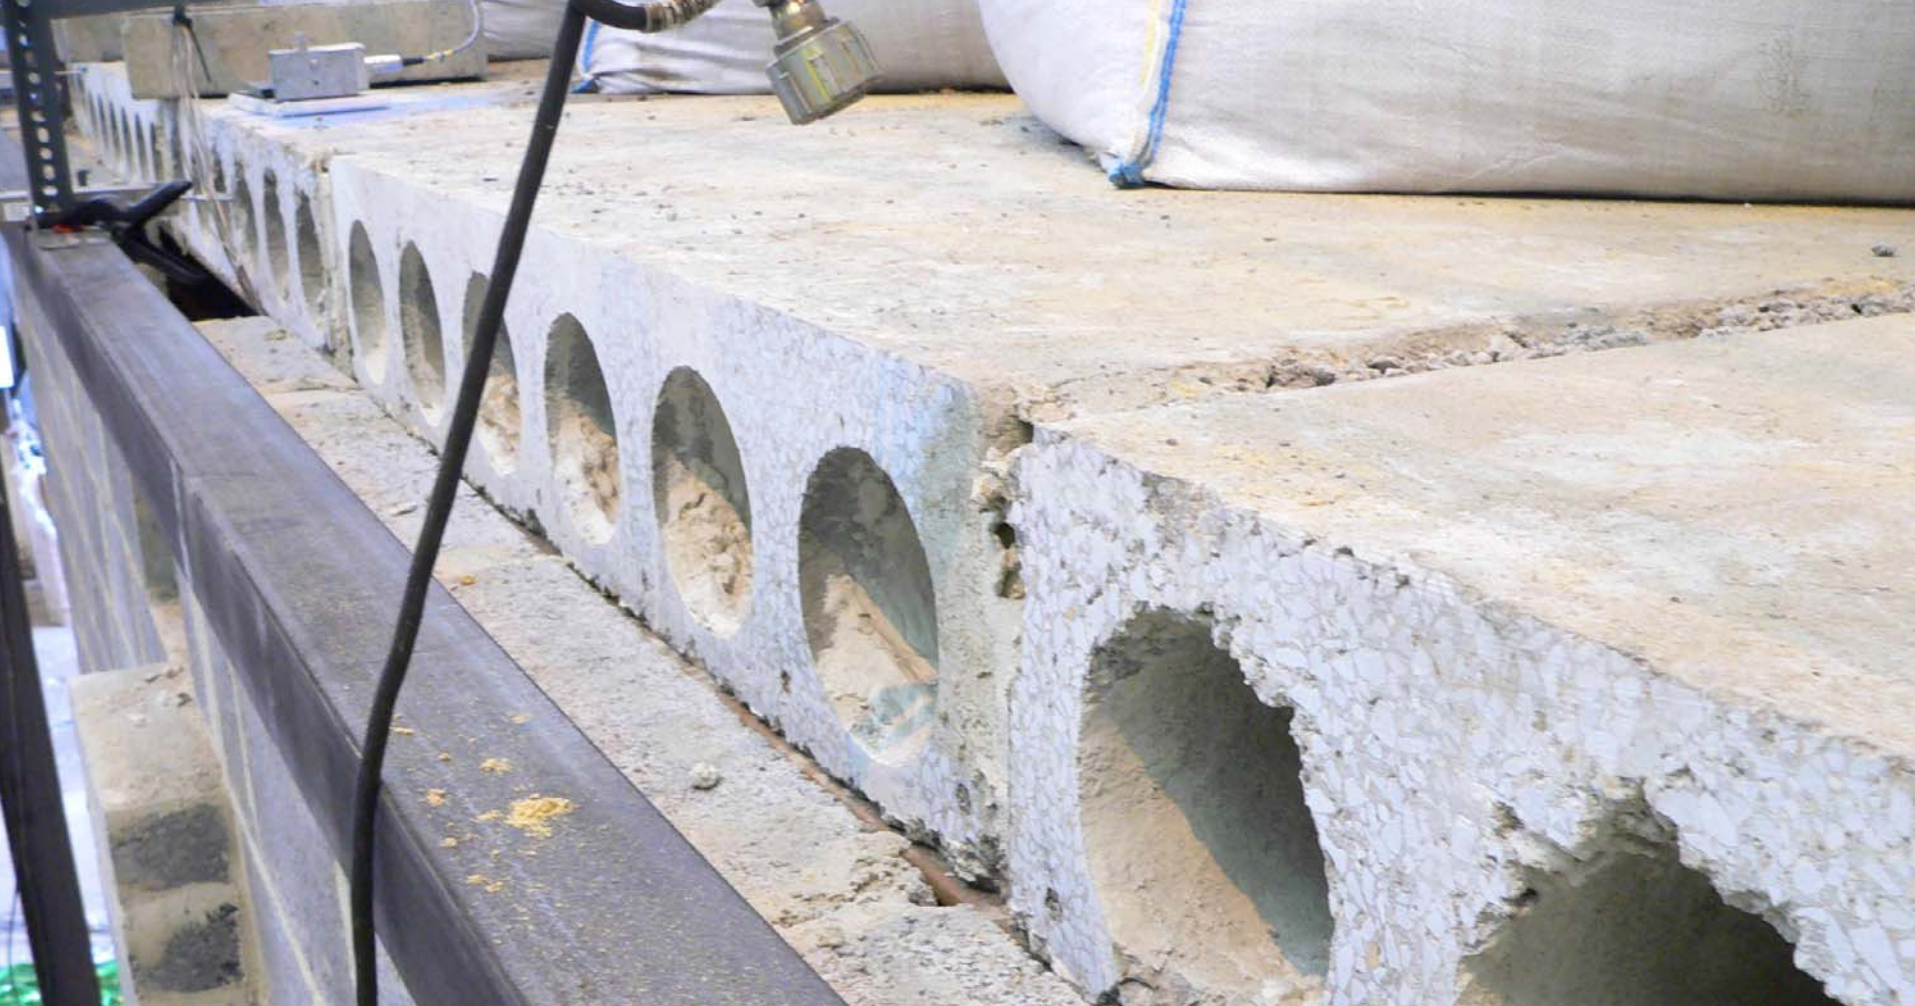
Test 1: Units sit directly on steel beams and grout placed between units and around columns

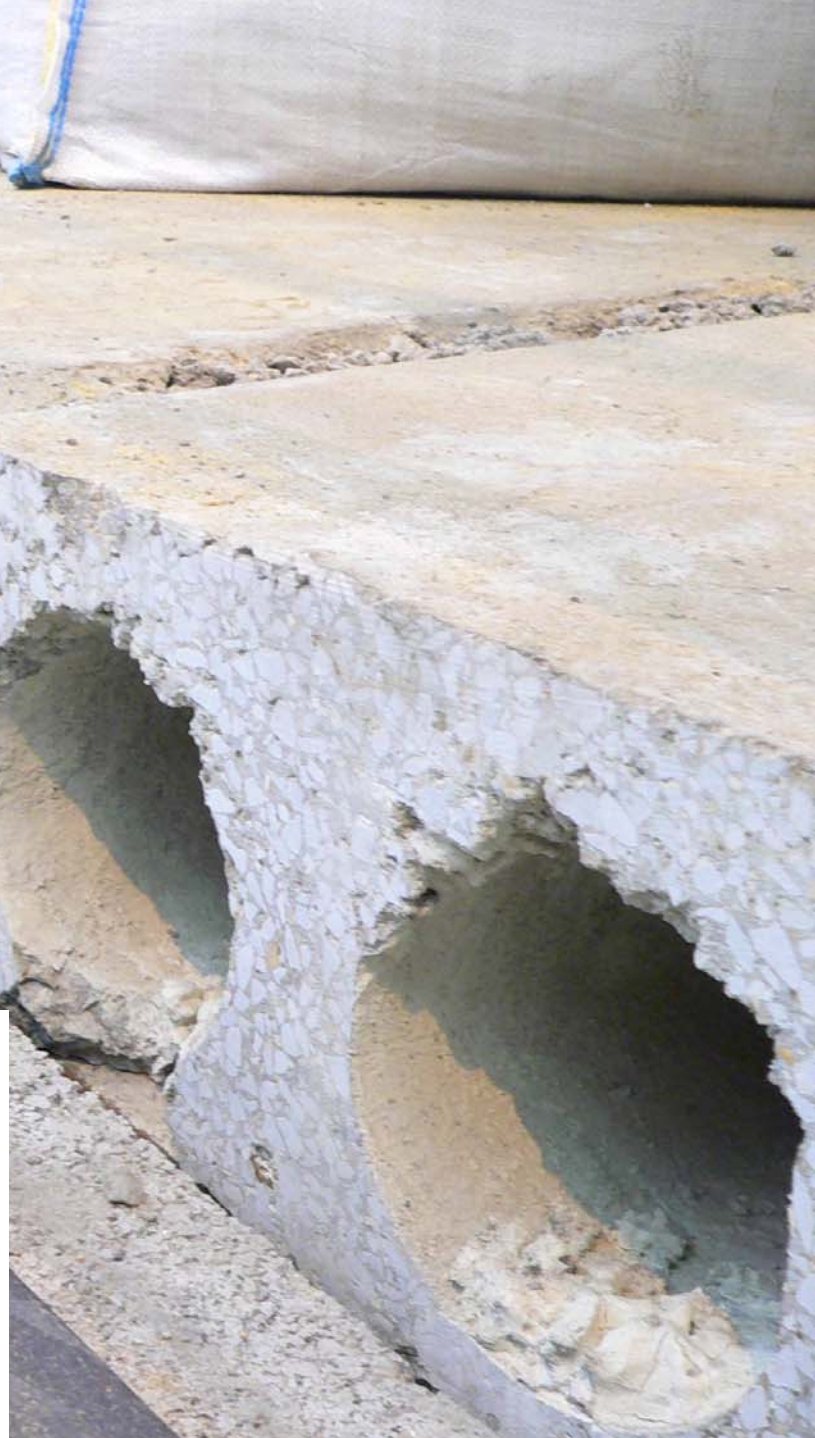
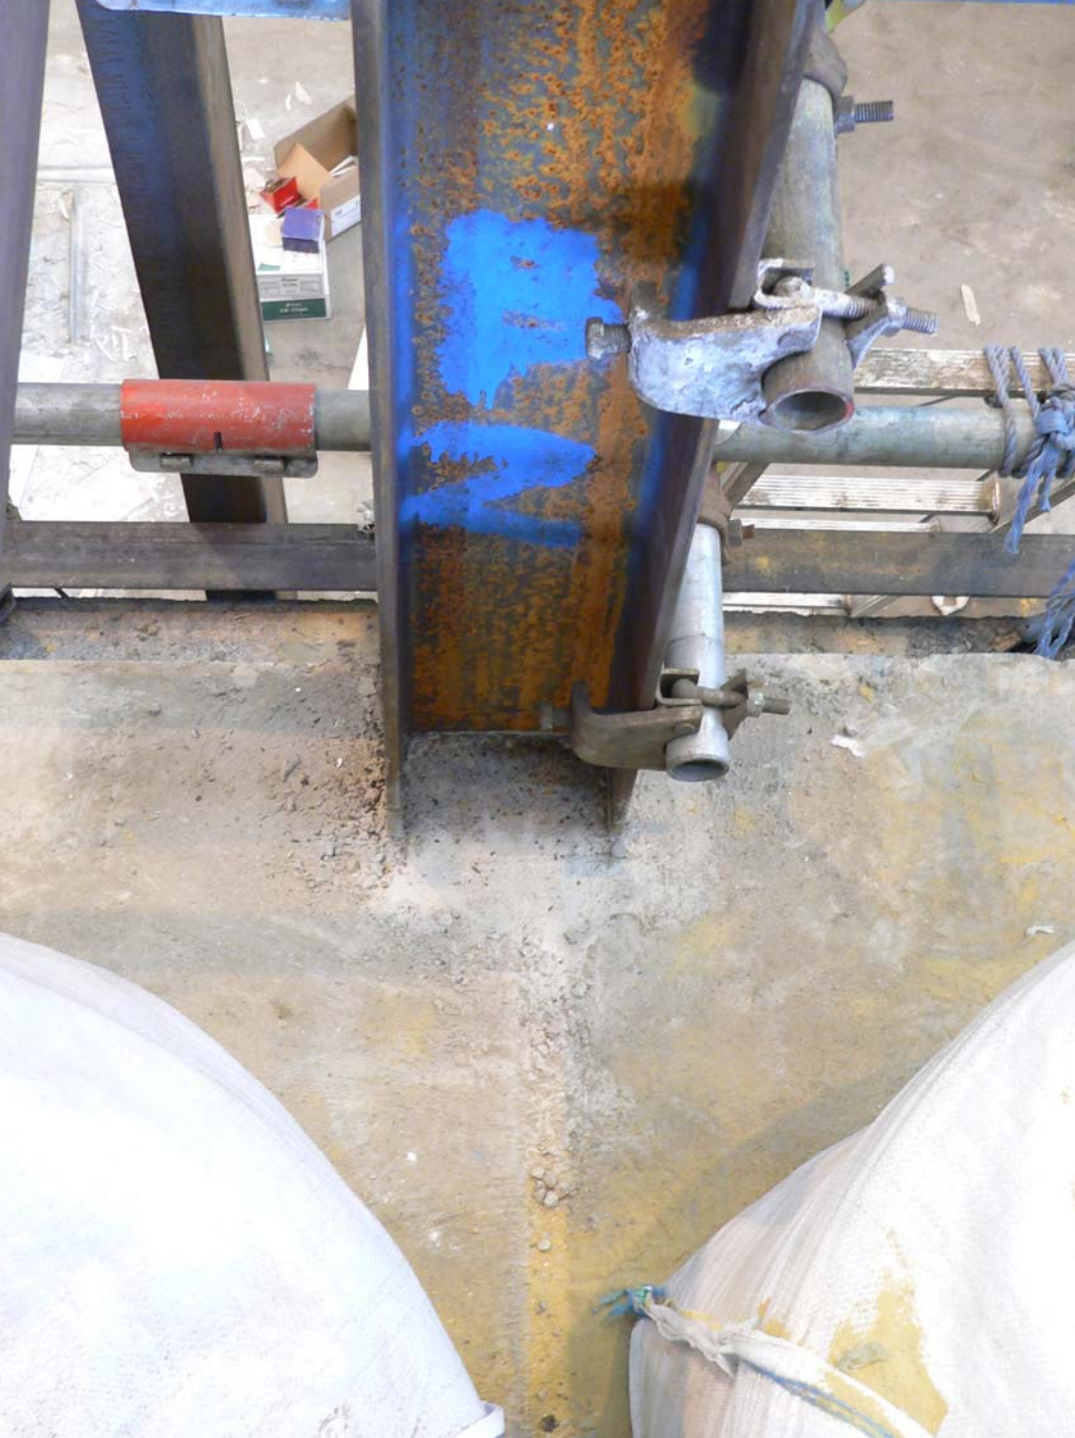
Test 1

Grout placed
between units and
around column

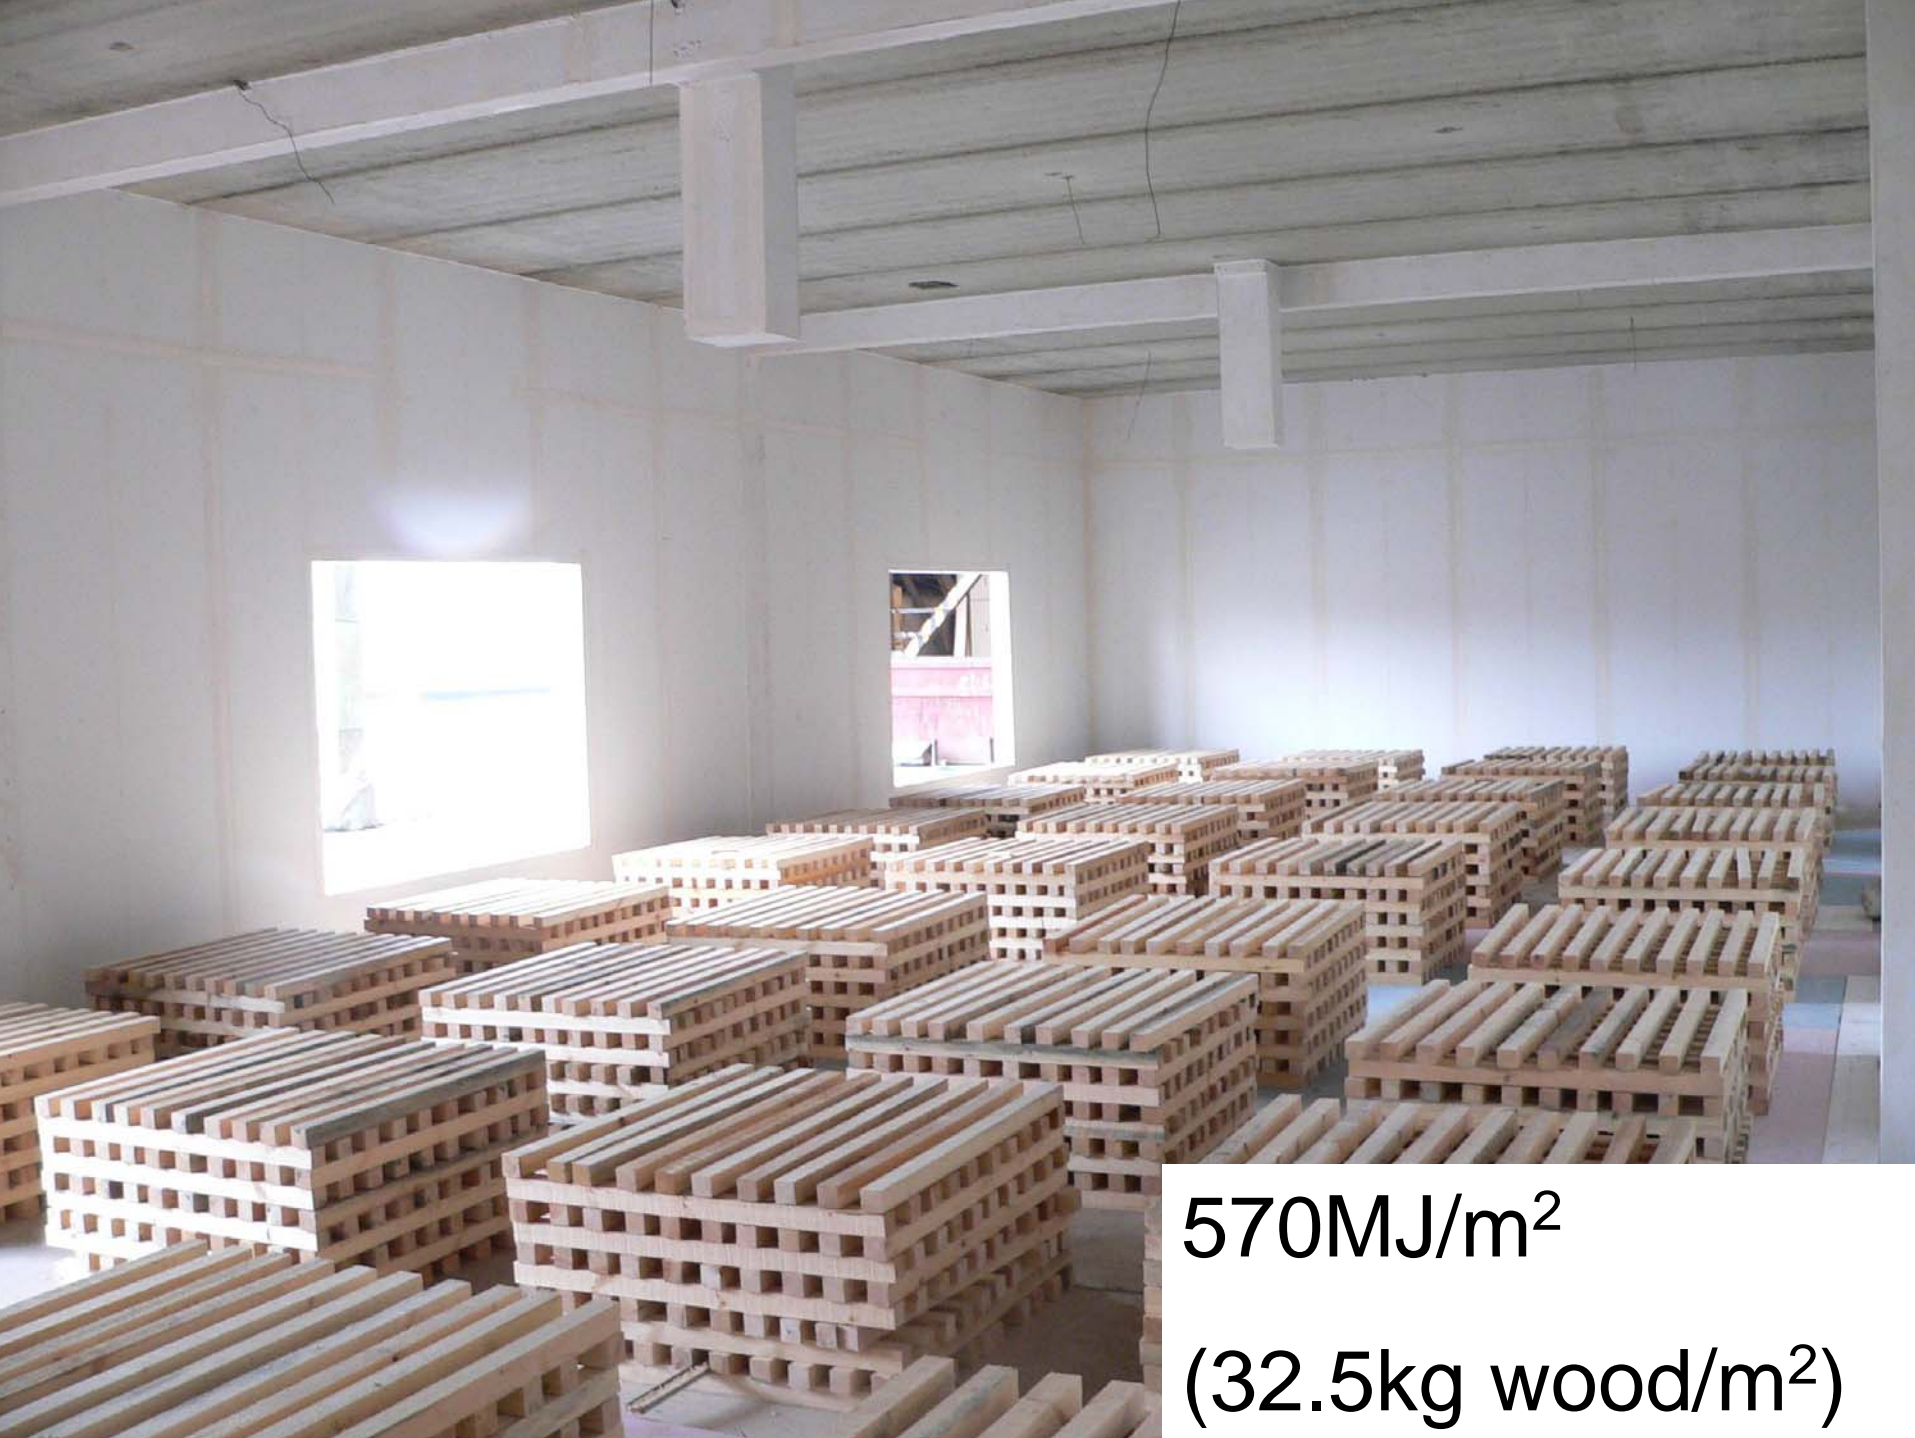
570MJ/m²

(32.5kg wood/m²)

Temperature [$^{\circ}\text{C}$]

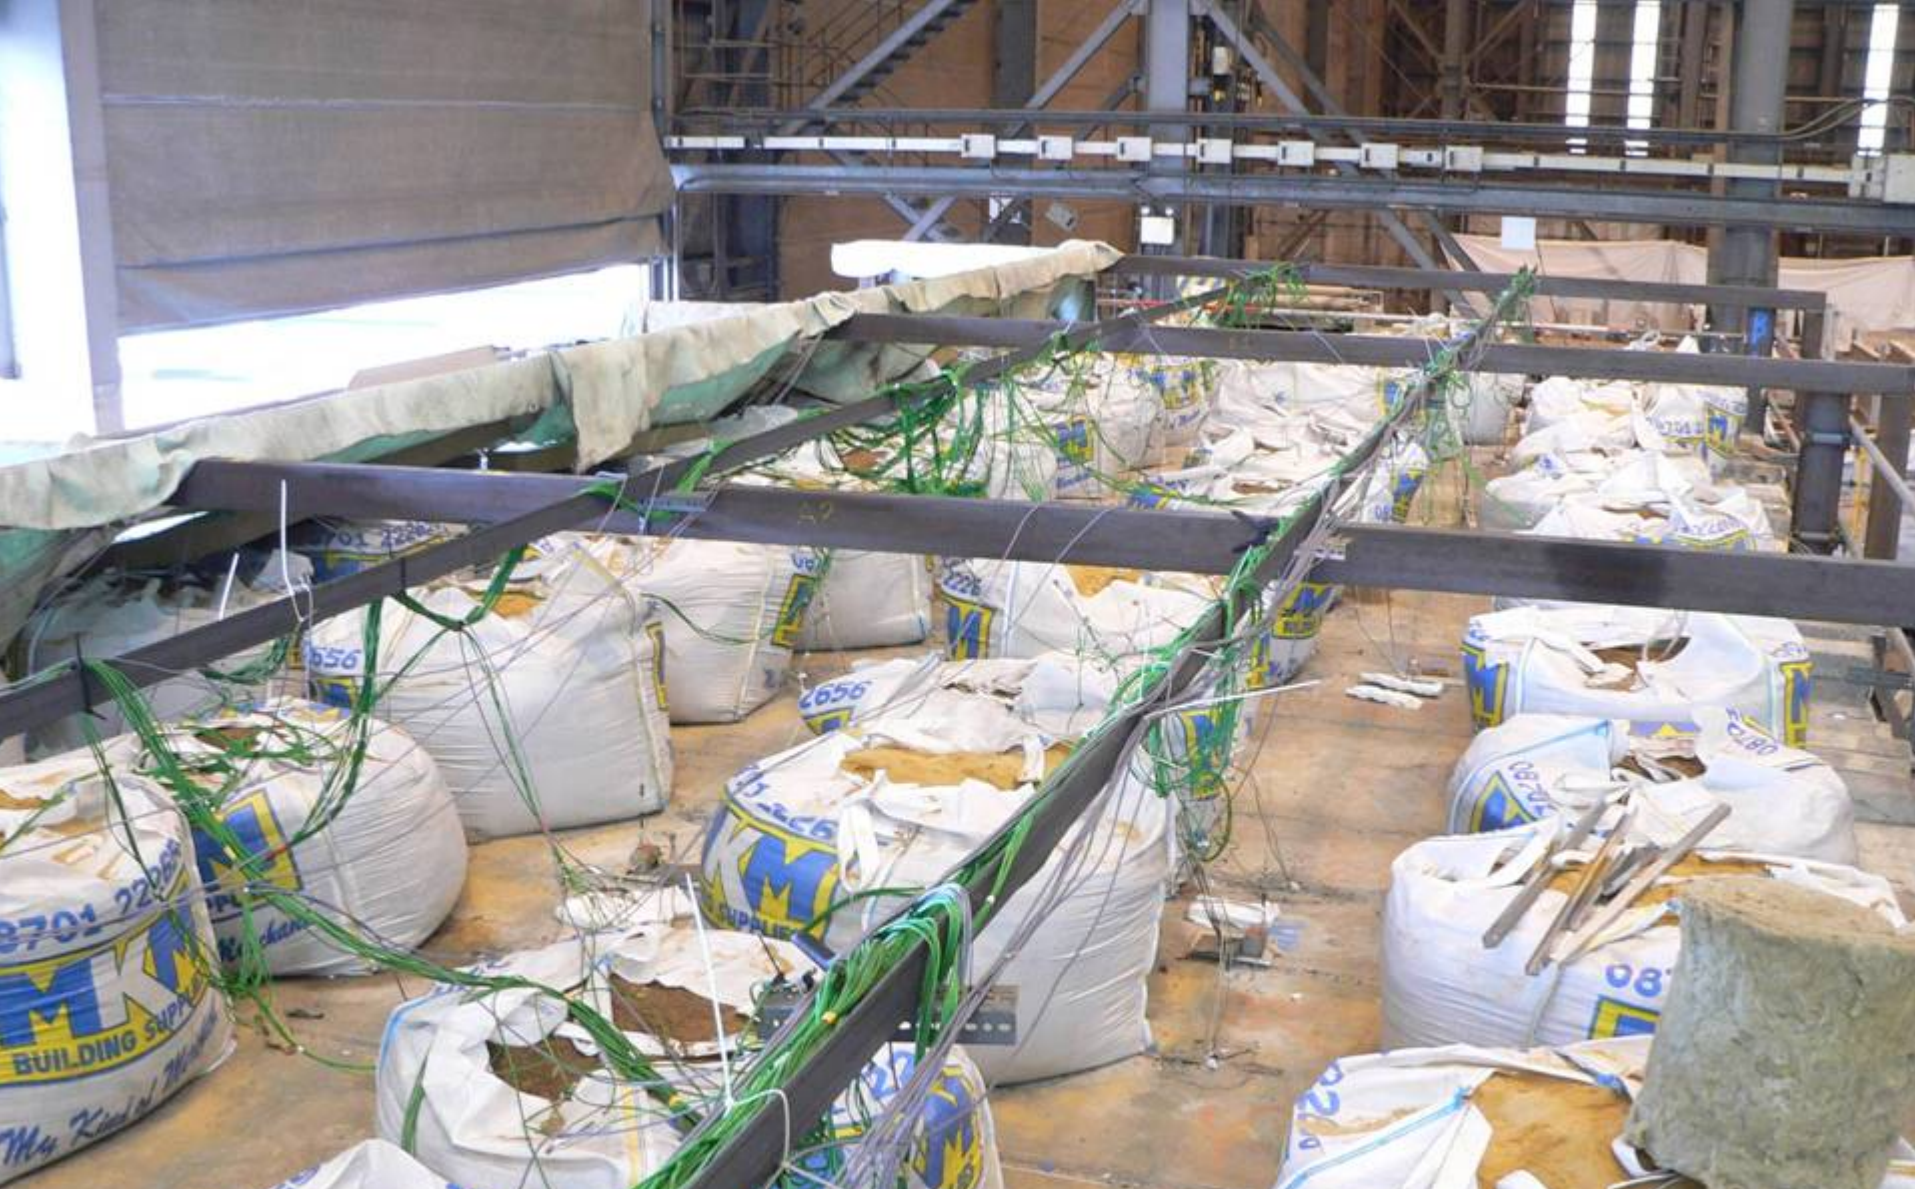
Total load = 7.67 kN/m^2 (Applied = 4.71 kN/m^2)

Load Ratios: 0.34 bending; 0.26 shear.

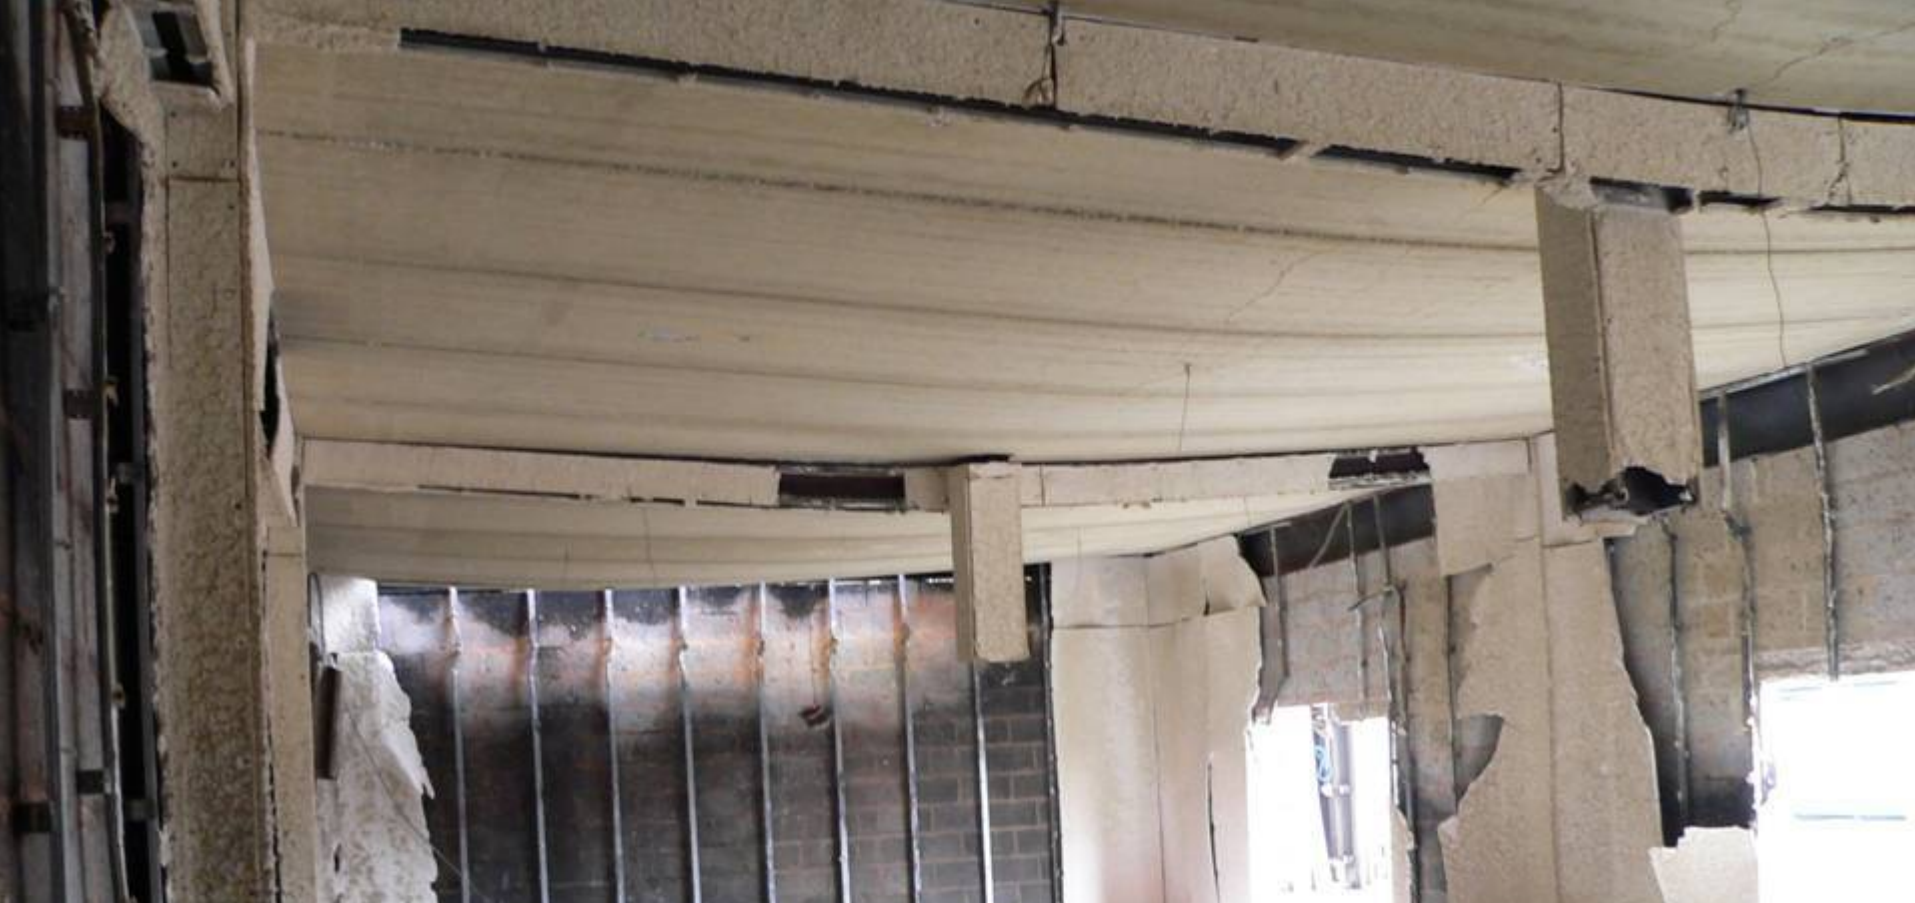
Design to BSEN1992-1-2

Maximum strand temp = 553°C

Flexural capacity = 39.7kNm

Applied load = 54.8kNm

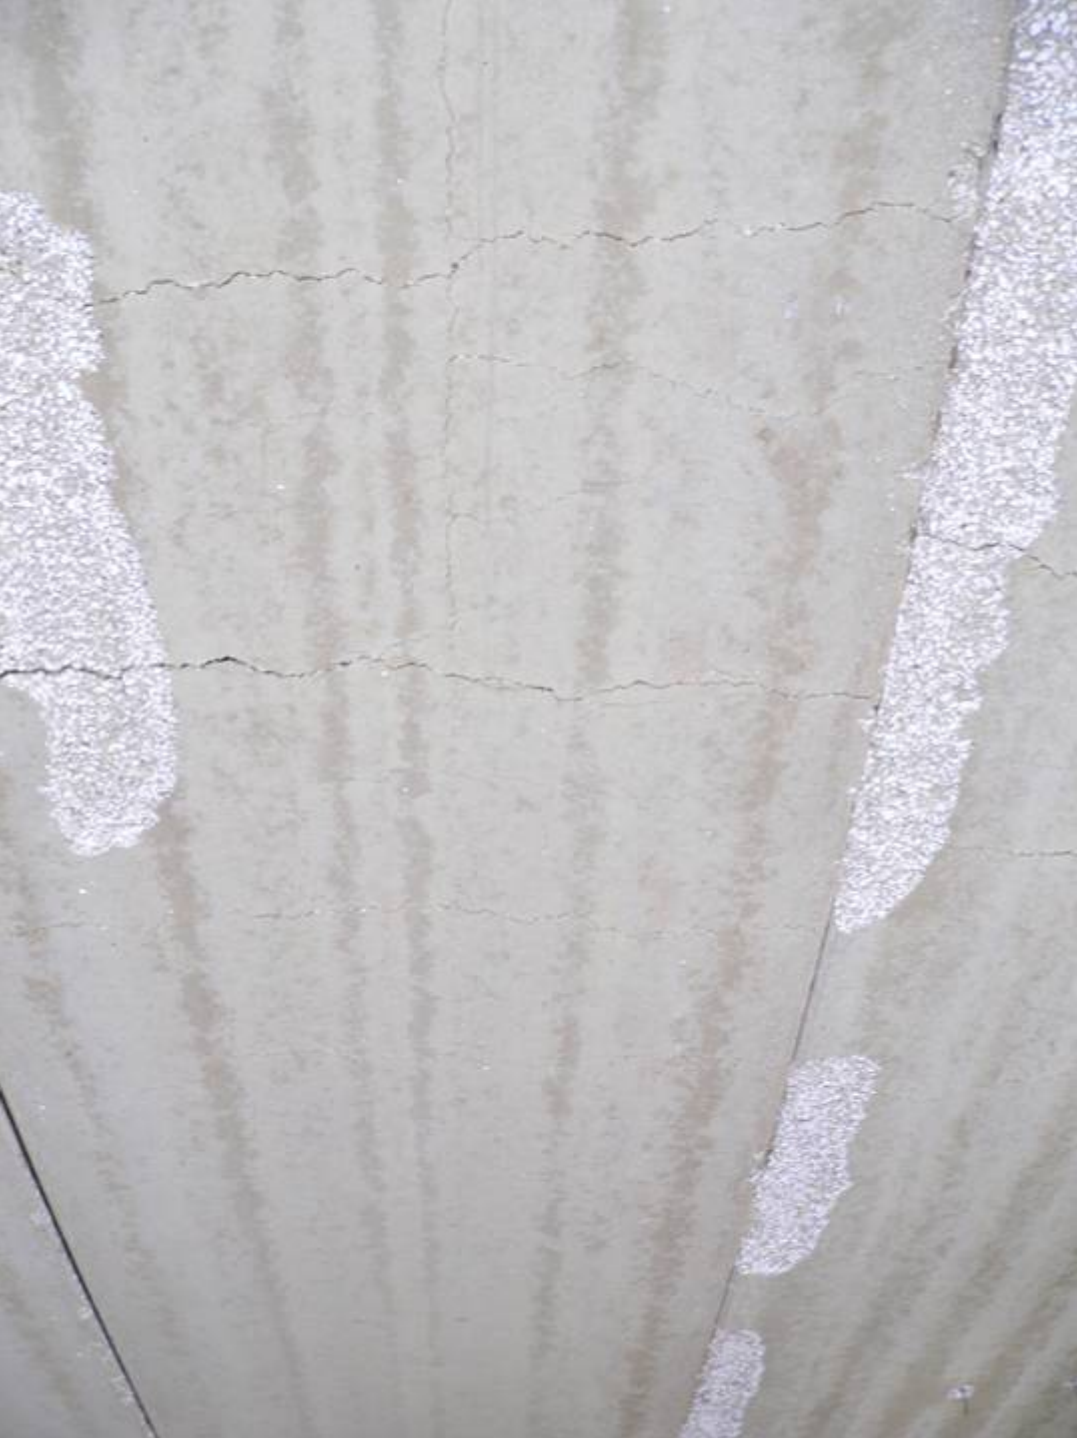
Test 1

**No significant
spalling**

- No significant spalling occurred.
- The parametric curve produced lower temps during the heating phase and should be addressed.
- Although the applied load was higher than the assumed office load the LR's of 0.34 and 0.26 were low. A range of LR's should be considered.

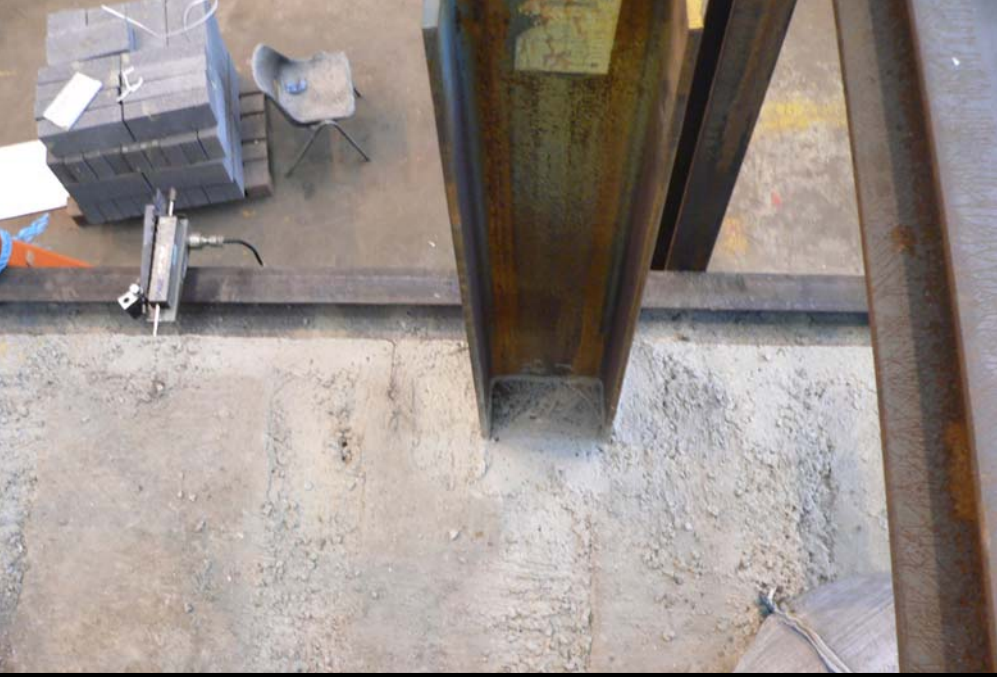
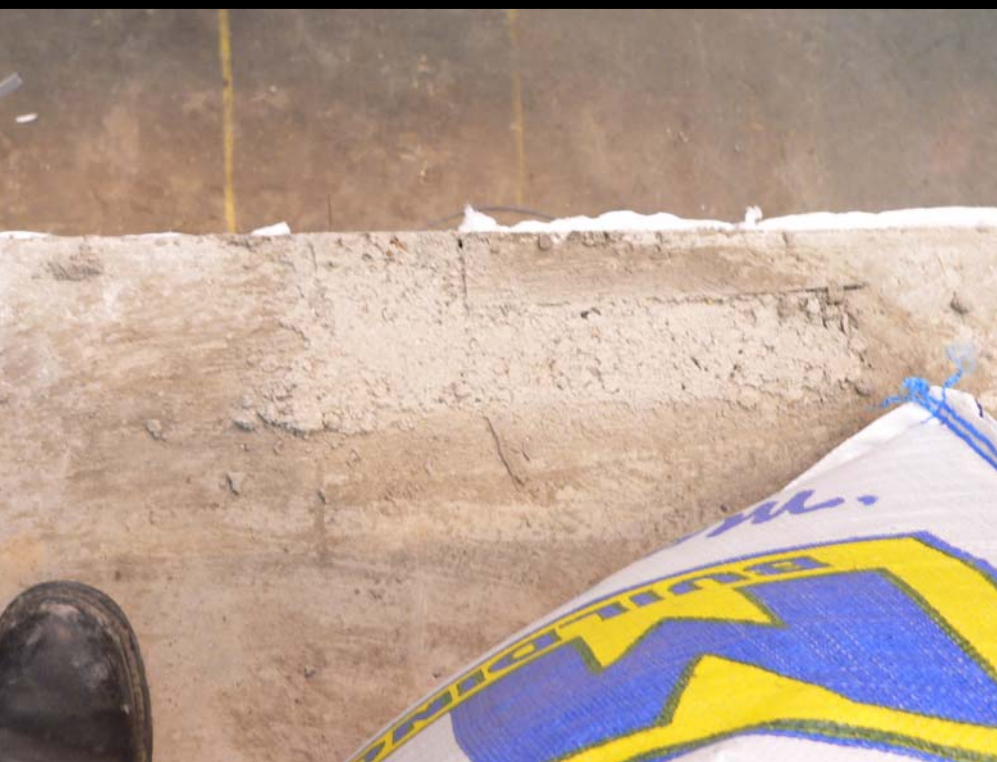
Test 2 : Additional reinforcement

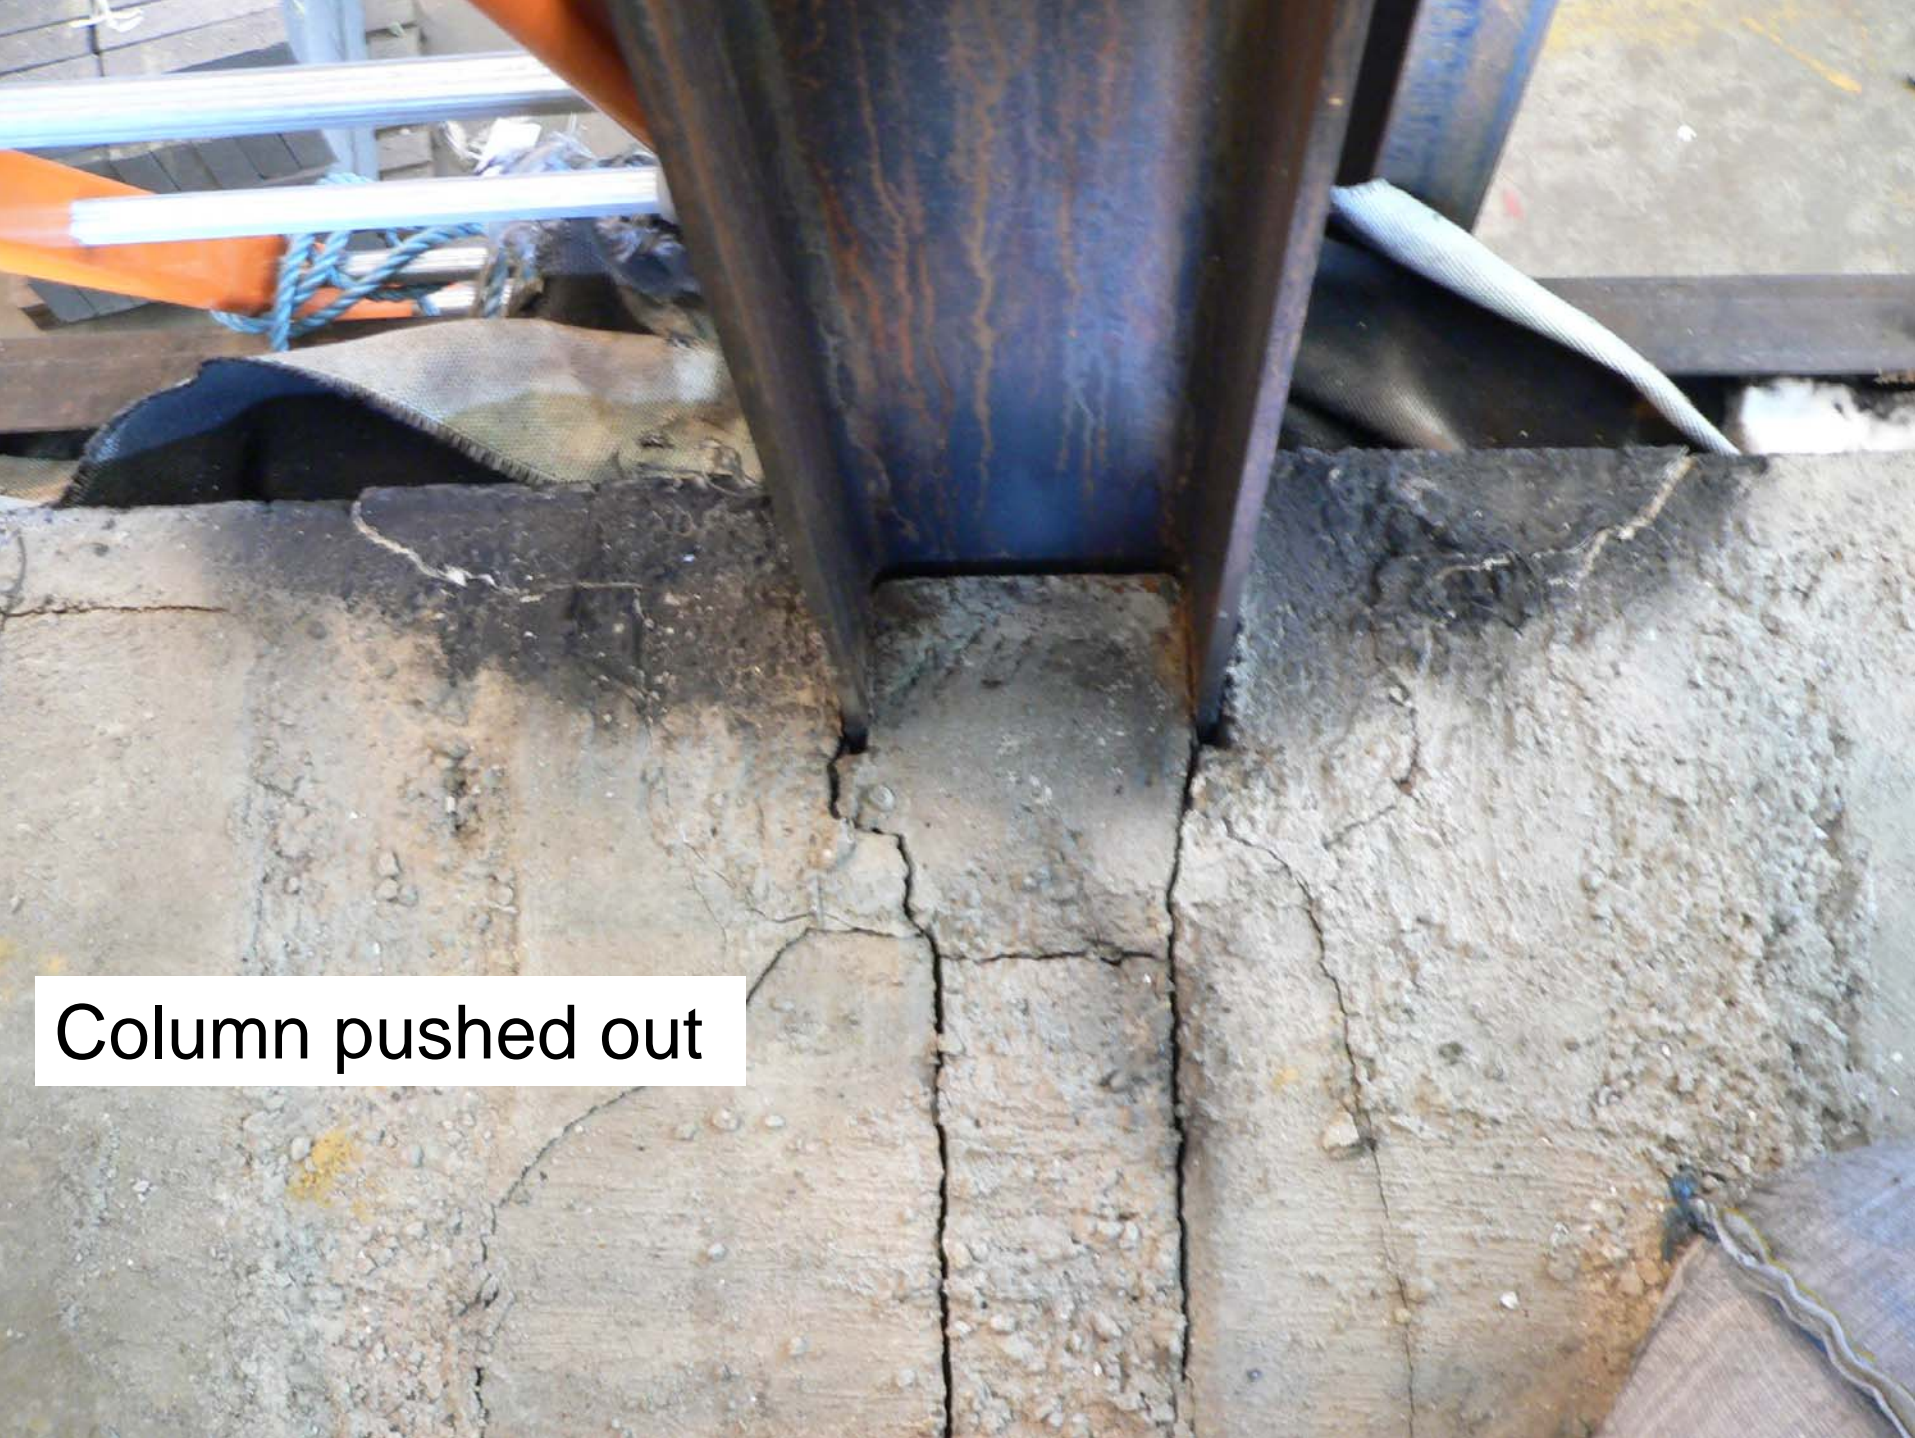
Column pushed out

Column displacement

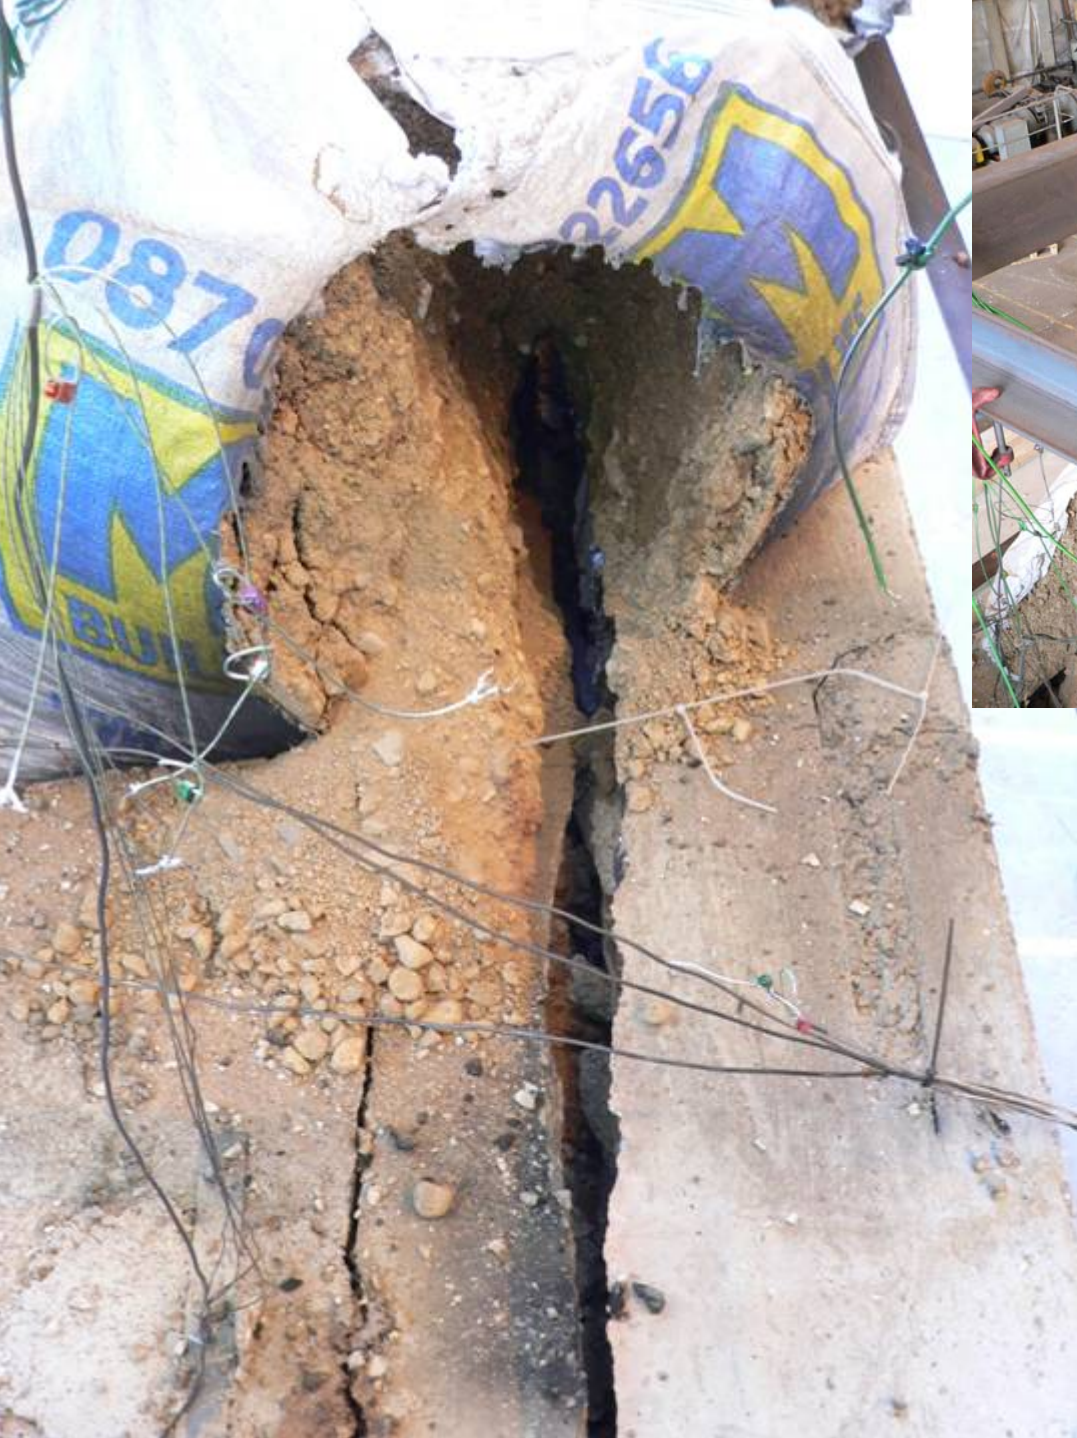
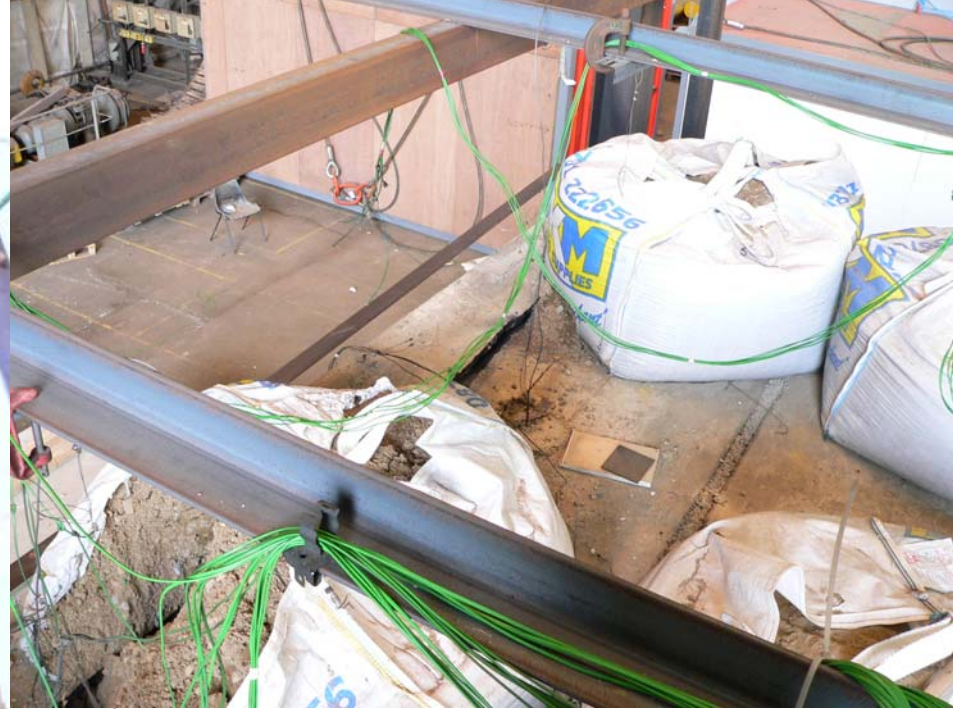
**Additional bars
kept unit in place**

**(Time of fracture
can be obtained
from data)**
