**Full-scale Fire Tests on
Hollowcore Floor System**

Colin Bailey: *University of Manchester*

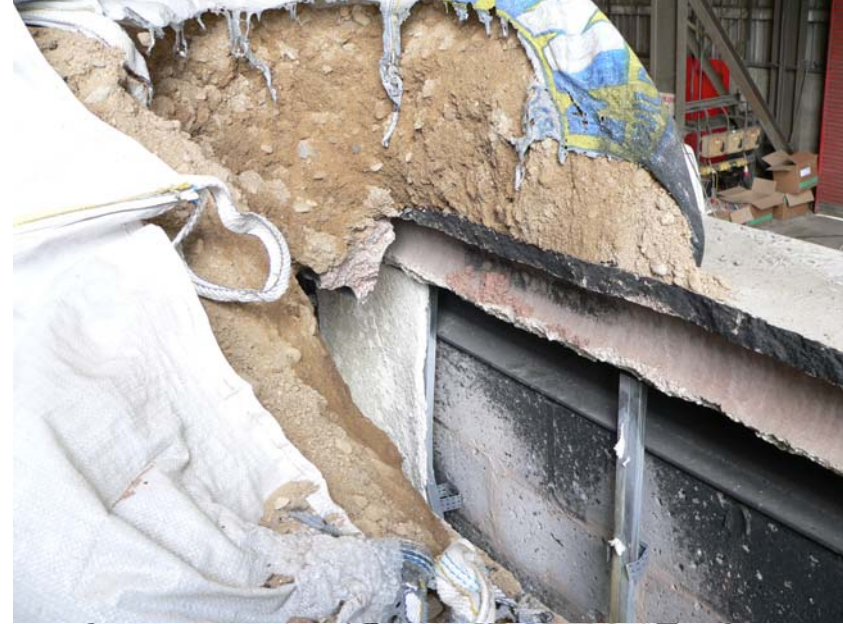
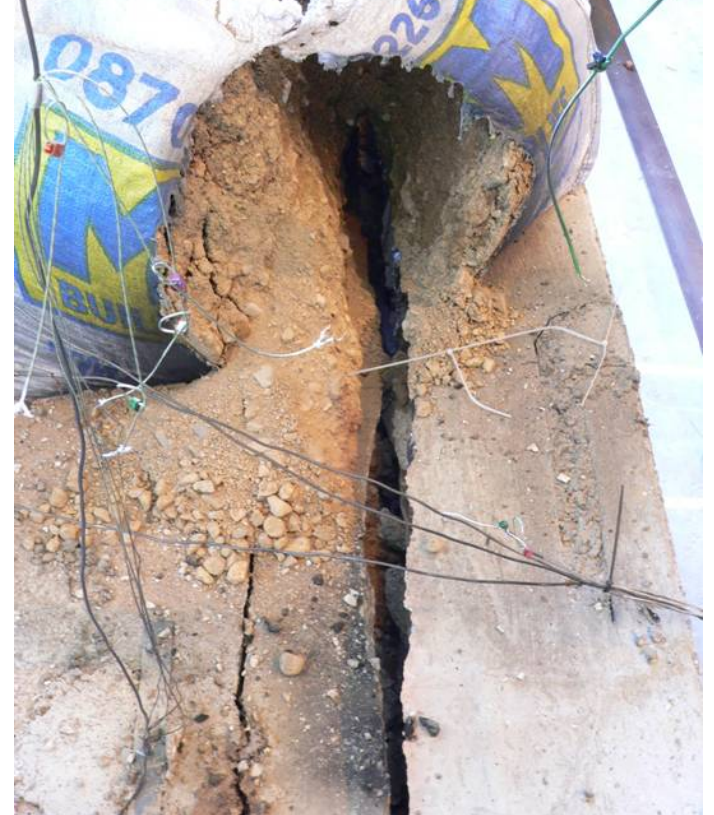
Fracture of end units:

Test 1: 87mins (576°C)
& 103 mins (394 °C)

Test 2: 76mins (870°C)
& 95mins (645°C)
